**Summary and Update of Site Investigation  
Buick City  
Report to EGLE  
July 15, 2020**

RACER TRUST  
BUICK CITY  
FLINT, MICHIGAN

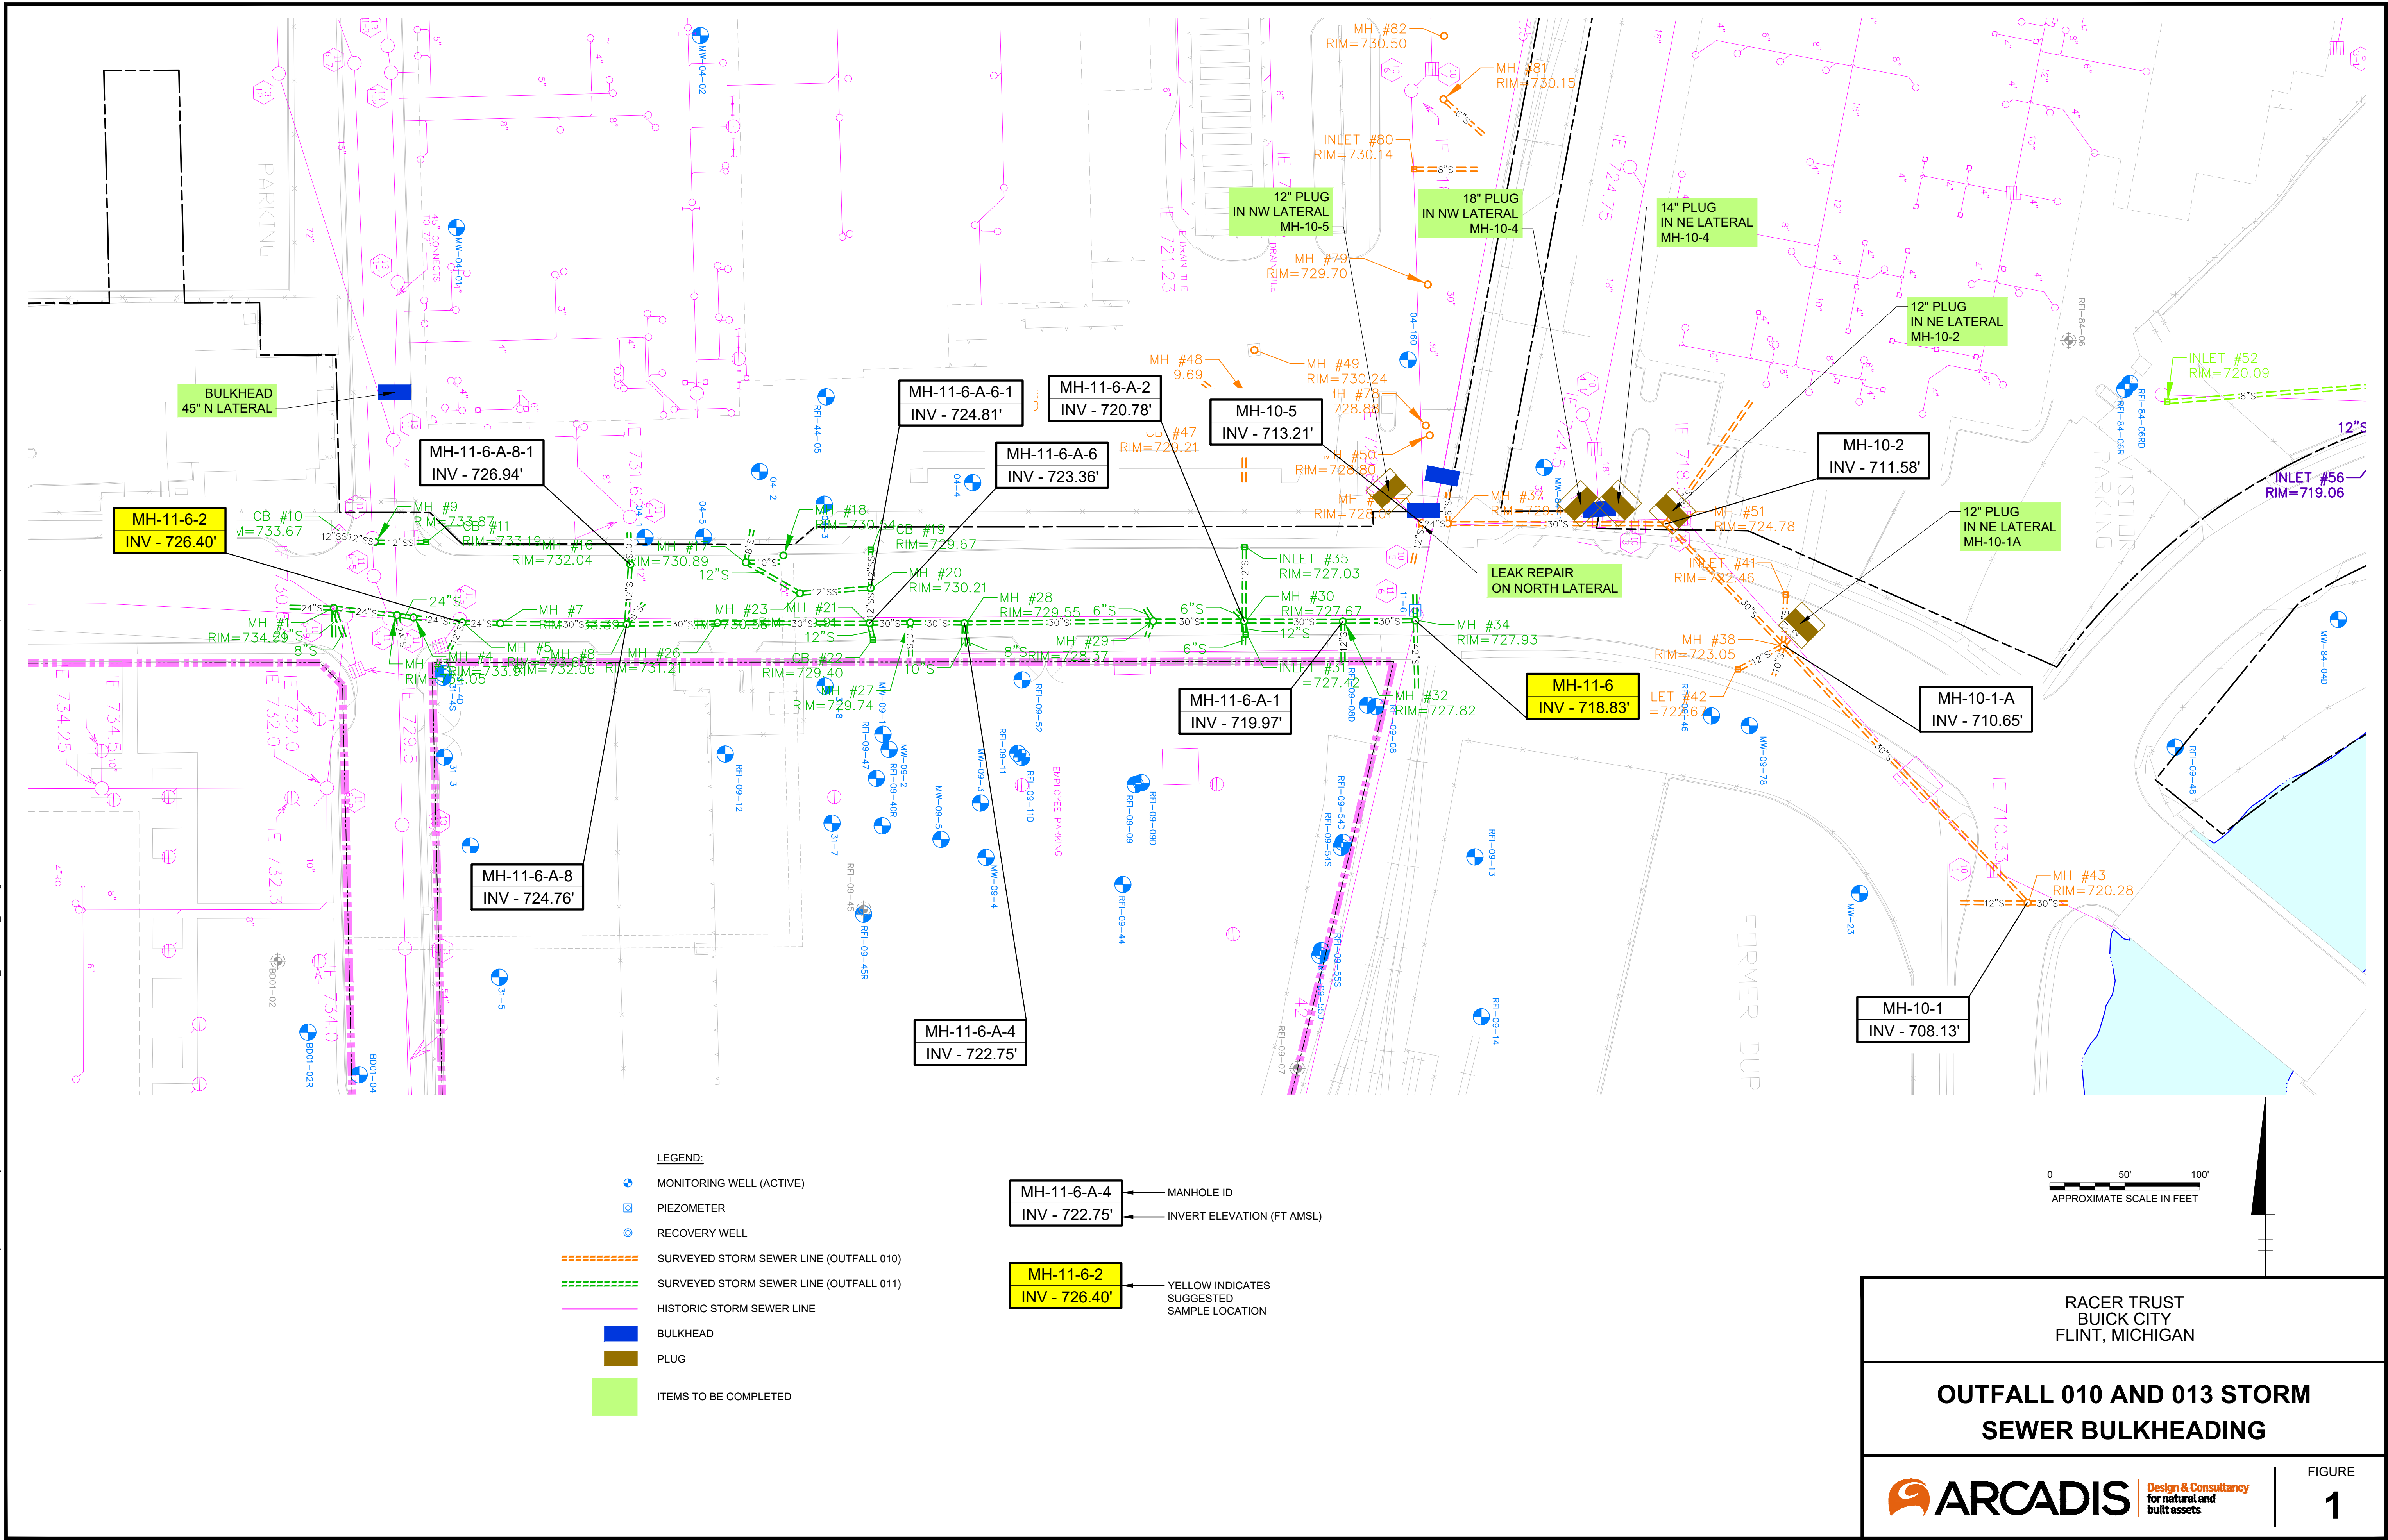
OUTFALL 010 AND 013 STORM  
SEWER BULKHEADING

Plugs were installed in select laterals along the **Outfall 010 storm sewer** in Hamilton Avenue (see **Exhibit 3-1**) the week of June 15<sup>th</sup>. A sample was collected from the Outfall 010 storm sewer the week of July 6<sup>th</sup> to assess PFAS impacts in the storm sewer following plugging activities. Those results are expected about the first week of August.

During the week of June 22, a bulkhead was installed at **Outfall 013** to eliminate the contribution from a lateral entering the main sewer at manhole MH 13-11 (see **Exhibit 3-1**). Samples were collected from the Outfall 013 storm sewer the week of July 6<sup>th</sup> to assess impacts following bulkheading activities. The sample results are expected by the first week of August.

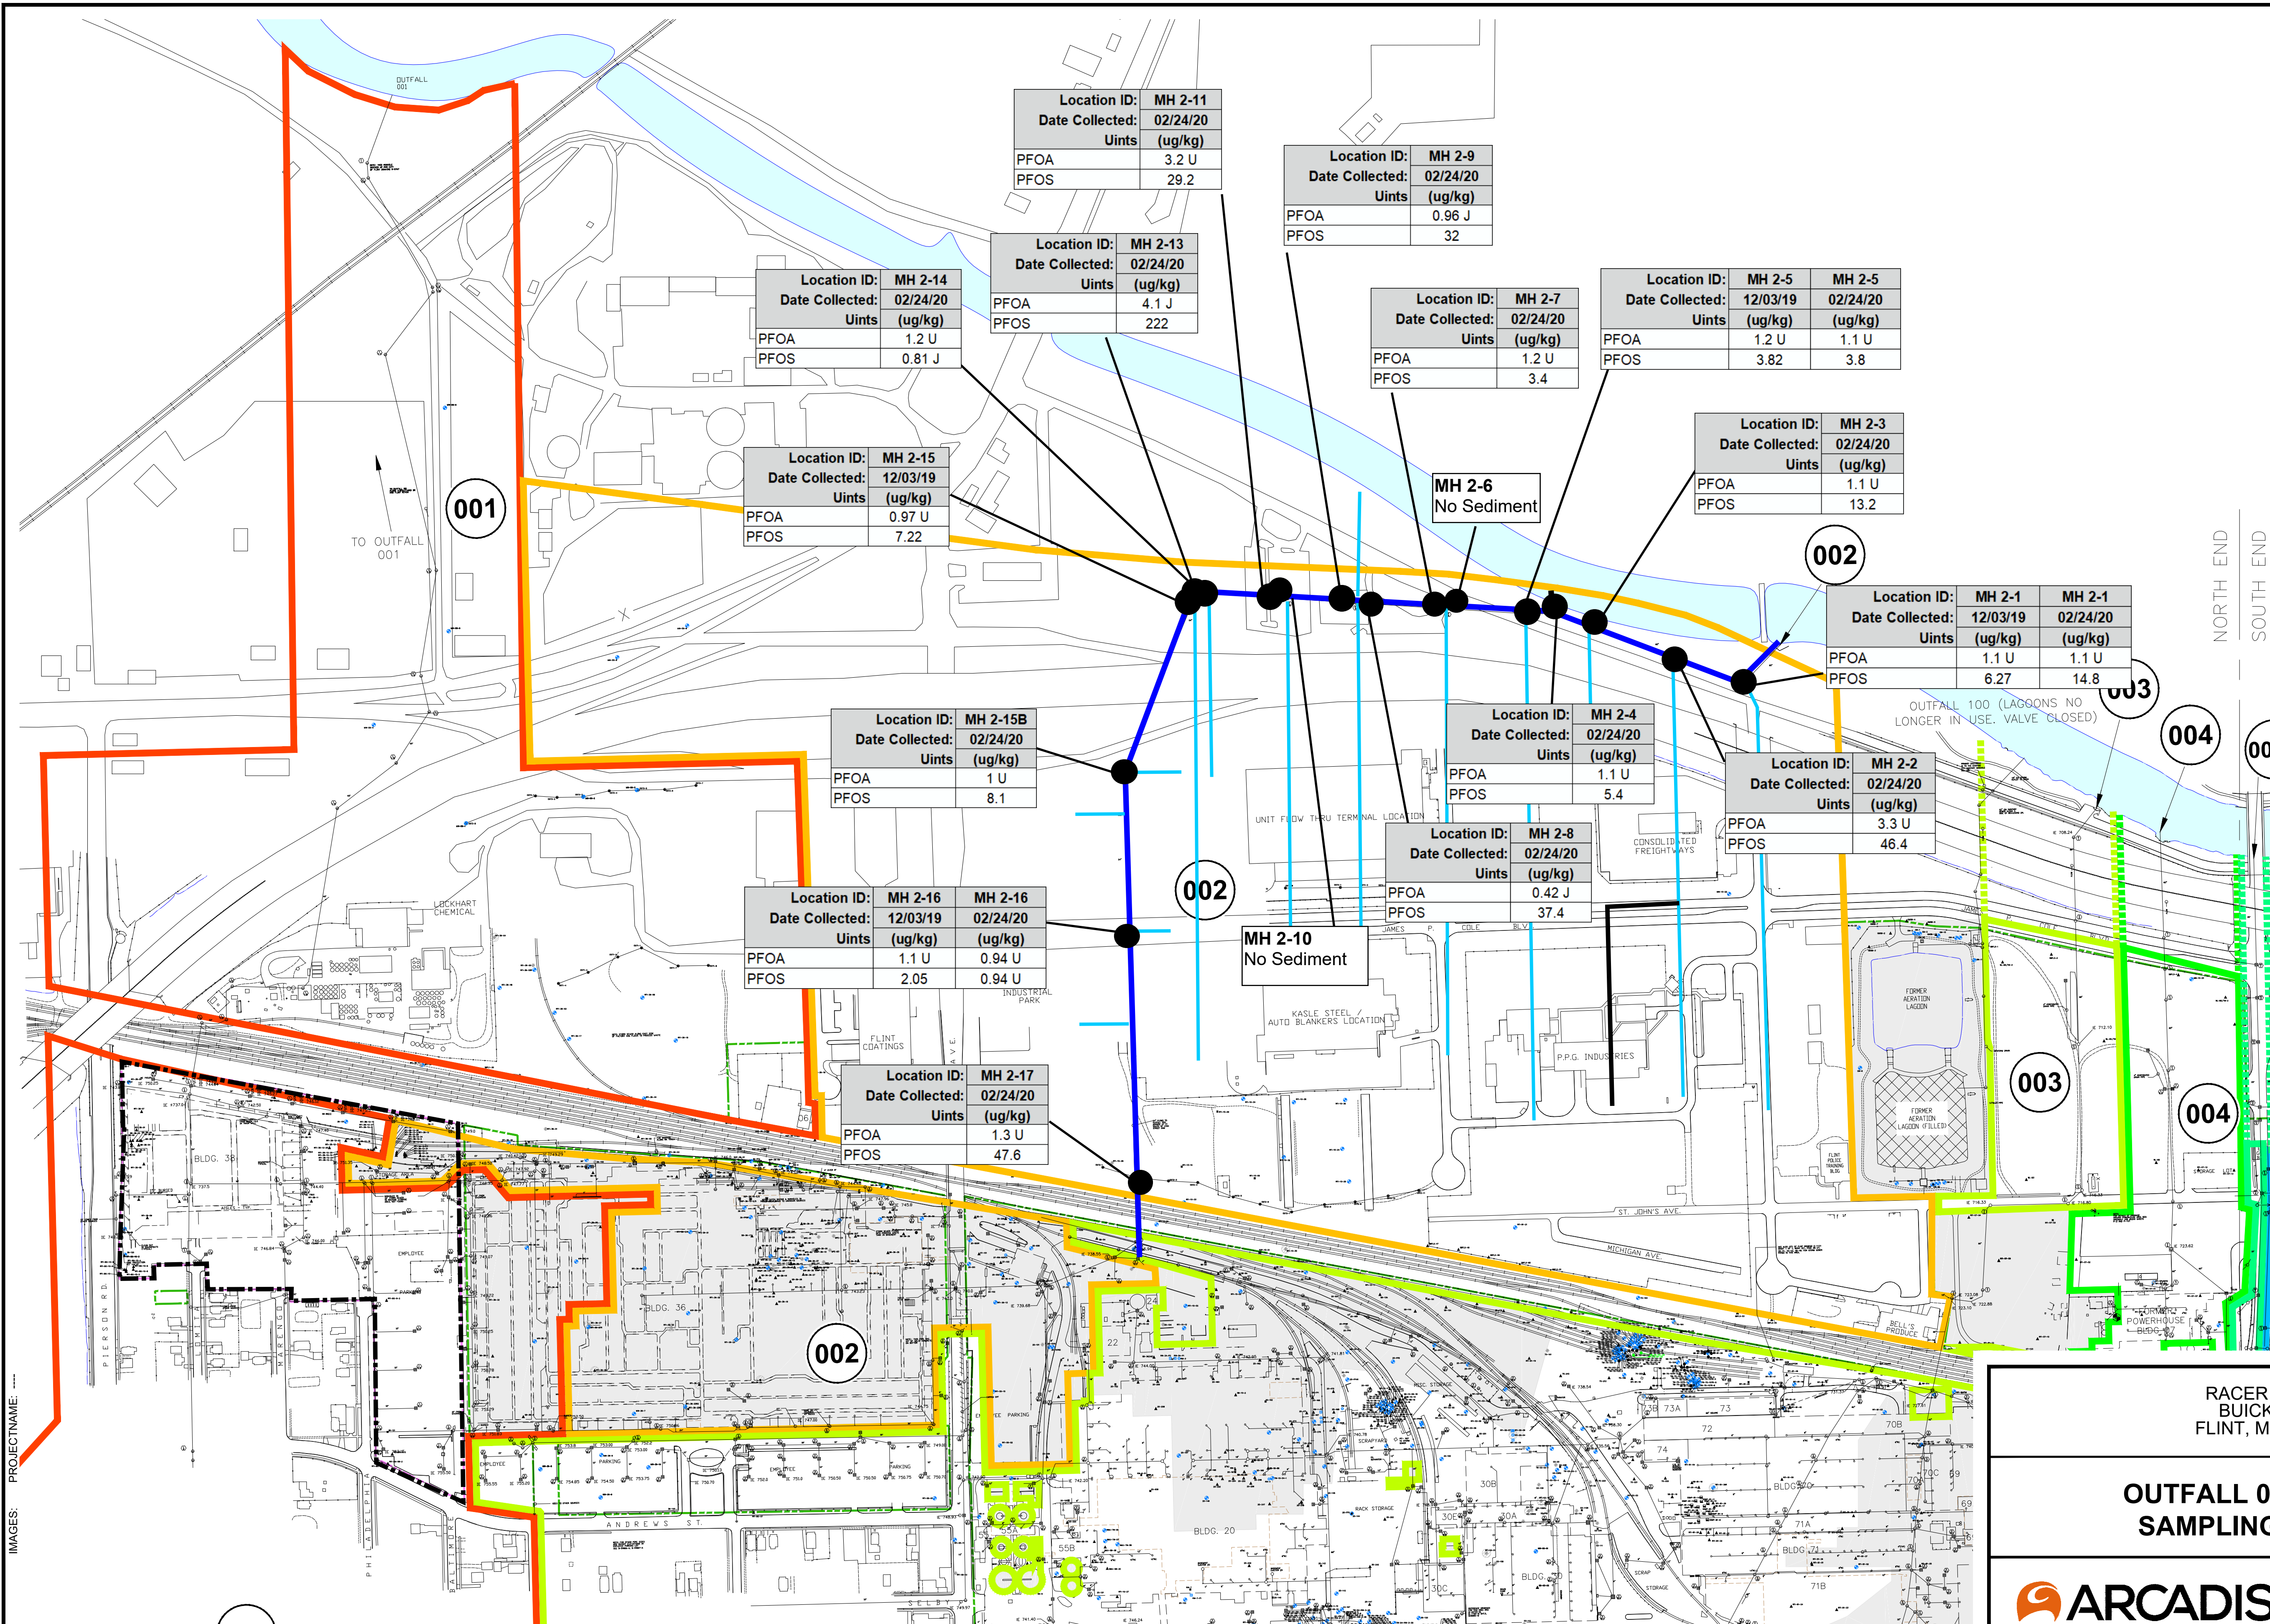
## OUTFALL 002 SEDIMENT SAMPLING LOCATIONS

Finally, with respect to **Outfall 002** the Buick City Site's contribution to 002 will be reconnected with the completion of the 003 reroute. To establish baseline conditions before the 003 reroute is reconnected, samples of sediments and stormwater were collected from the outfall 002 stormwater line downgradient of the previously installed bulkhead to assess the condition of 002 before the reroute is completed and activated. Elevated levels of PFAS were found in both water and sediment, but not in adjoining groundwater samples.(see **Exhibits 4-1, 4-2, and 4-3**)

To investigate the possible source of this PFAS, samples were collected in December 2019 and February 2020 from manholes located in the Factory 36 Area north of Stewart Avenue, upgradient of the bulkheads – which did not detect PFOA/PFOS. However, samples collected from between the bulkheads installed at MH 2-20 and MH 2-18 detected PFOS at concentrations ranging from 1,200 ng/L to 22,600 ng/L. Water samples collected downgradient of the Site in the Outfall 002 storm sewer detected PFOS at concentrations ranging from 895 ng/L to 6,760 ng/L. (see **Exhibit 4-1**) While PFAS may be present in the storm sewer it was not infiltrating from groundwater (the sewer is several feet below the groundwater table) and as noted the groundwater samples in the area contained PFAS at levels significantly lower than inside the storm sewer by orders of magnitude. A more complete memo summarizing this work will be submitted in August.

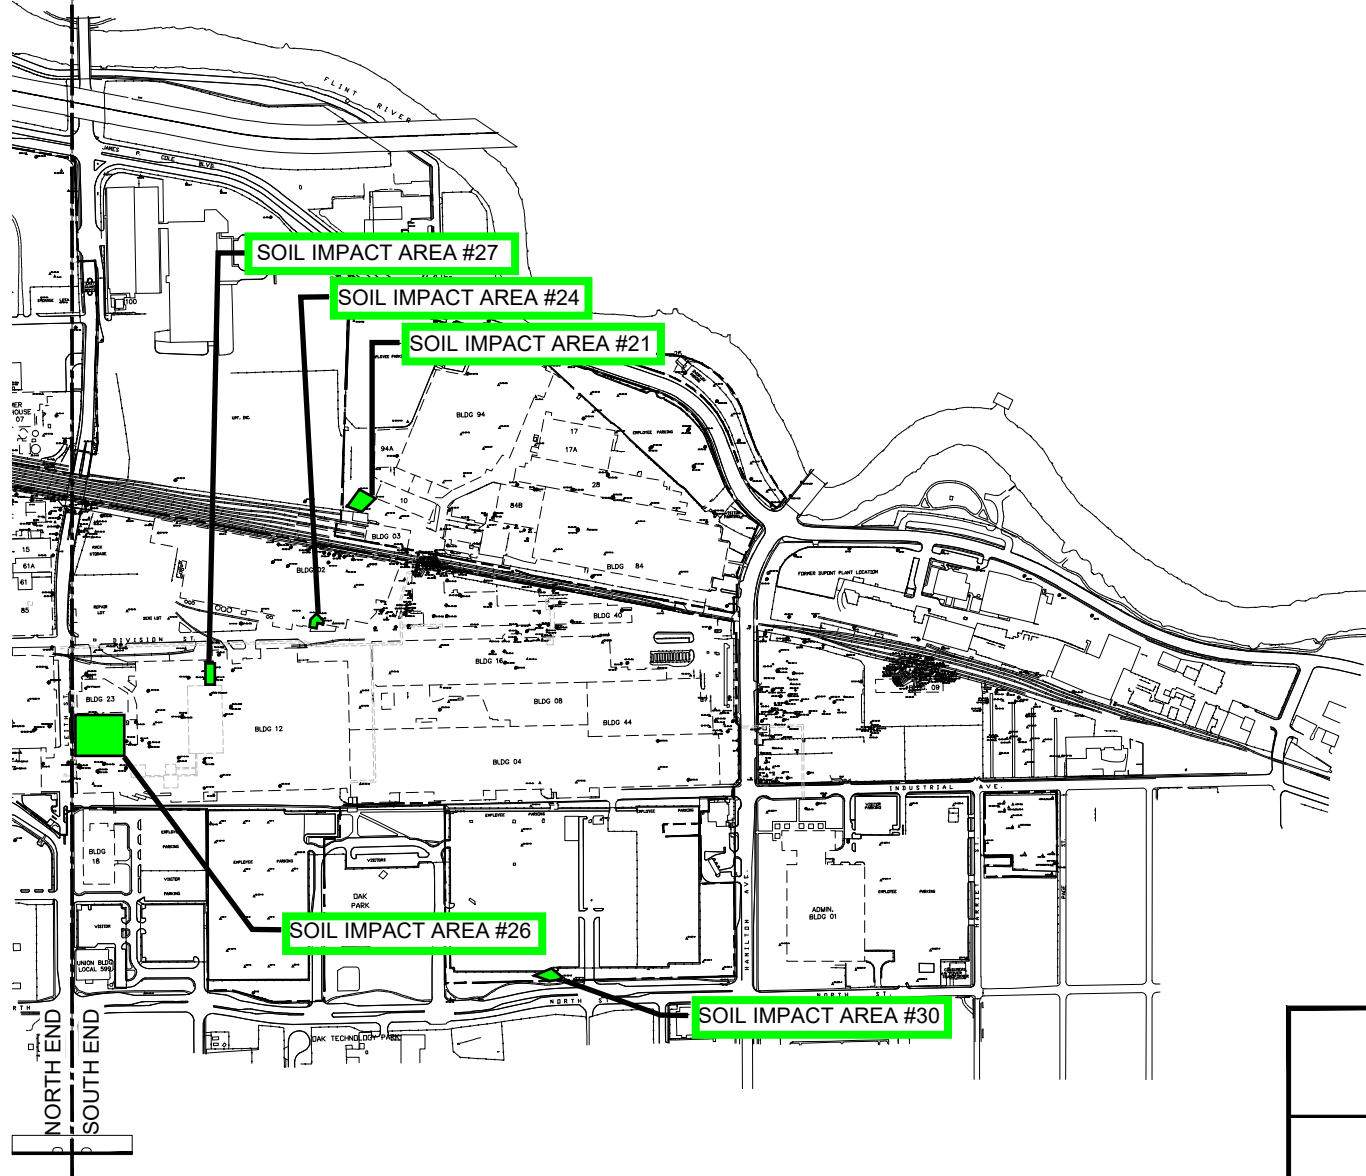
**SOUTHEND  
LEAD IMPACT SOILS**

However, elevated levels of lead in soils are present on site and a plan to properly and safely manage those soils during construction and remediation is important to prevent human exposure and assure these materials are safely managed during future construction and remediation activities. The attached maps (see **Exhibits 7-1, 7-2, and 7-3**) show the locations where lead soil concentrations exceed 900 ppm which is the direct contact limit. Sample results in soil vary widely from less than 10ppm to as high as 385,000 ppm at one location. This is most certainly an outlier and likely attributable to a “nugget” particle of lead collected with the soil sample. Additional testing is planned to confirm that the lead present in these soils has not adversely impacted groundwater and can be relocated within designated areas of the site during construction activities under proper regulatory controls.

The majority of the soils sampled for lead are located either at depth or below existing concrete slabs and do not present a health hazard in their present location/condition. Any lead in soils not covered by concrete is covered by soils or aggregate. A “Materials Management Plan (MMP)” is being prepared that will guide future work on the site to ensure safe and proper work is performed and that required measures to address these lead soils will be implemented during construction. The MMP will include conditions that will ensure that lead found in surface soils or from excavations at levels that could present a possible health hazard (e.g. contact, dust, etc.) will be managed to prevent health hazards while remediation and redevelopment are underway.
