# **RACER TRUST LANSING PLANTS 2, 3, & 6**

**2022 Fourth Quarter Progress Report | January 15, 2023**

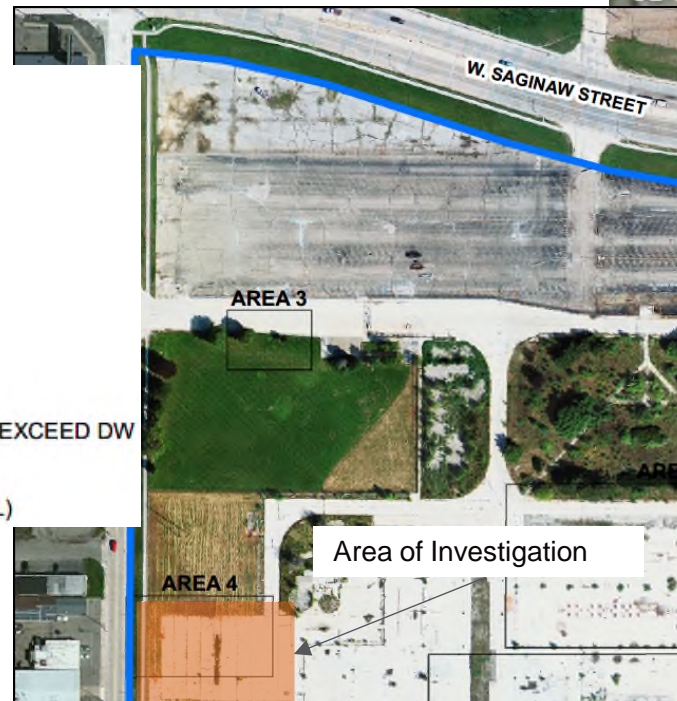
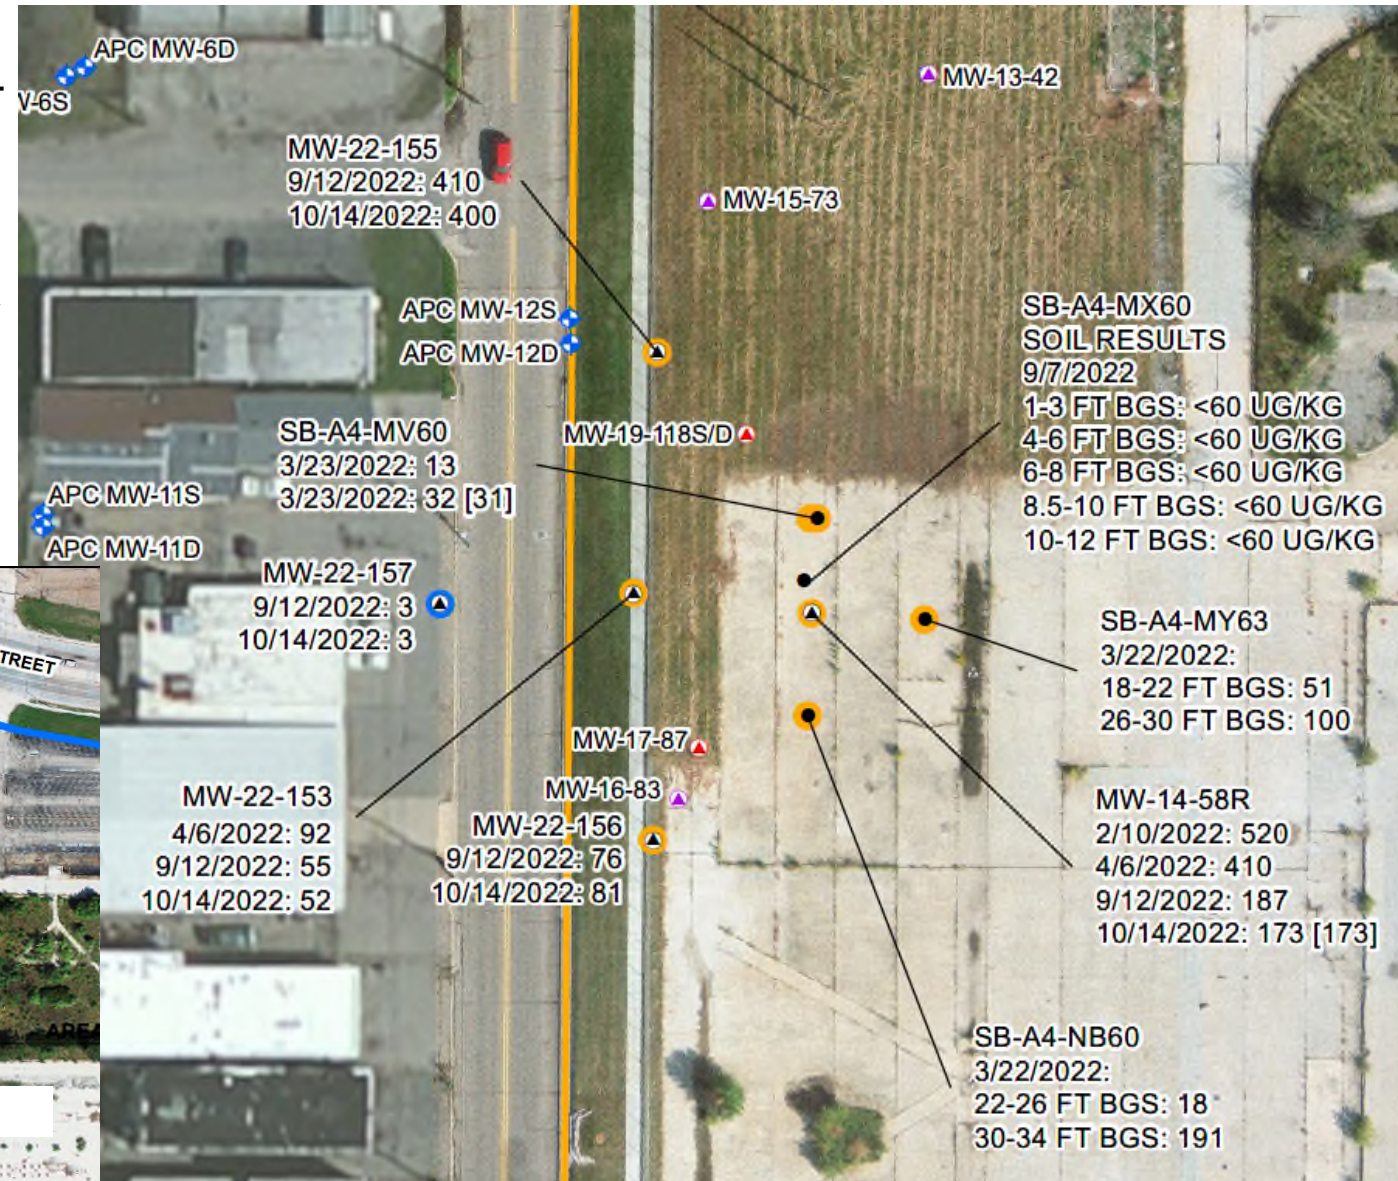
On-going investigation to evaluate 1,4-dioxane at well MW-14-58R. Additional work completed:

- One soil boring to 15 feet below grade adjacent to MW-14-58R (SB-A4-MX60):
  - Collected 5 Soil samples
  - All Non-Detect for VOCs, including 1,4-dioxane
- Installation of three additional perched monitoring wells for a total of five wells within the 25-30 ft below grade sand seam
- Review of the boring logs suggests the 25-30 ft below grade sand seam is part of an outwash channel

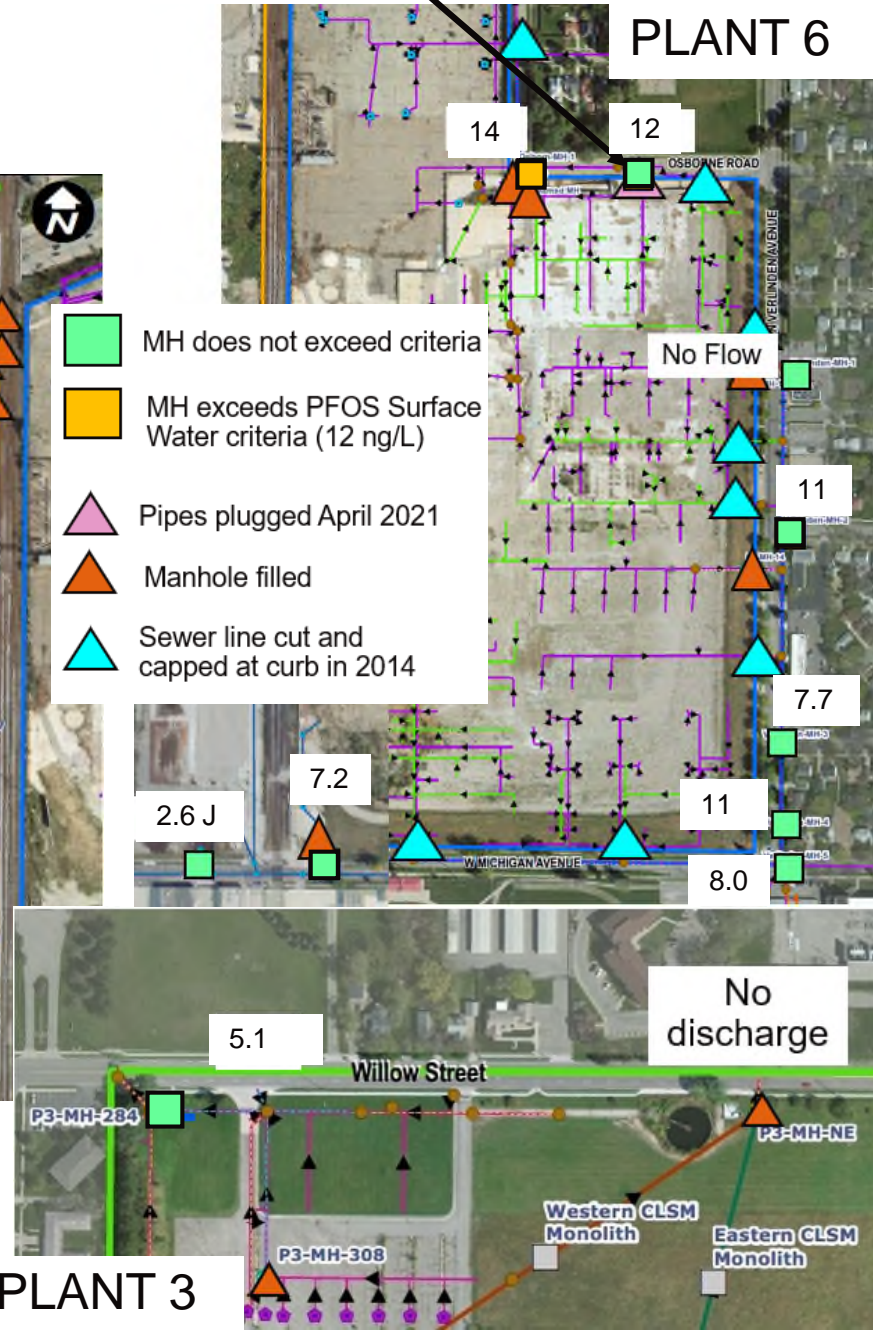
- Inspected downstream of Osborn-MH-1
    - Confirmed separate sanitary and storm sewer until Stanley and Genesee
    - Noted filled pipe running east from Stanley-MH-2 (located at Drexel and Stanley intersection)
    - Only pipes coming in/out of Stanley-MH-1, 2, and 3 are the main line confirmed to connect the structures and pipes running straight to catch basins
  - Stanley-MH-2 PFOS: 17 ng/L
  - Stanley-MH-3 PFOS: 14 ng/L
- Consistent with Osborn-MH-1 14 ng/L
