RACER TRUST  
ECKLES ROAD SITE  
LIVONIA, MICHIGAN

Project No. 12573440  
Date September 2025

PRB INJECTION BORING LOCATIONS

Attachment G – Photo Log

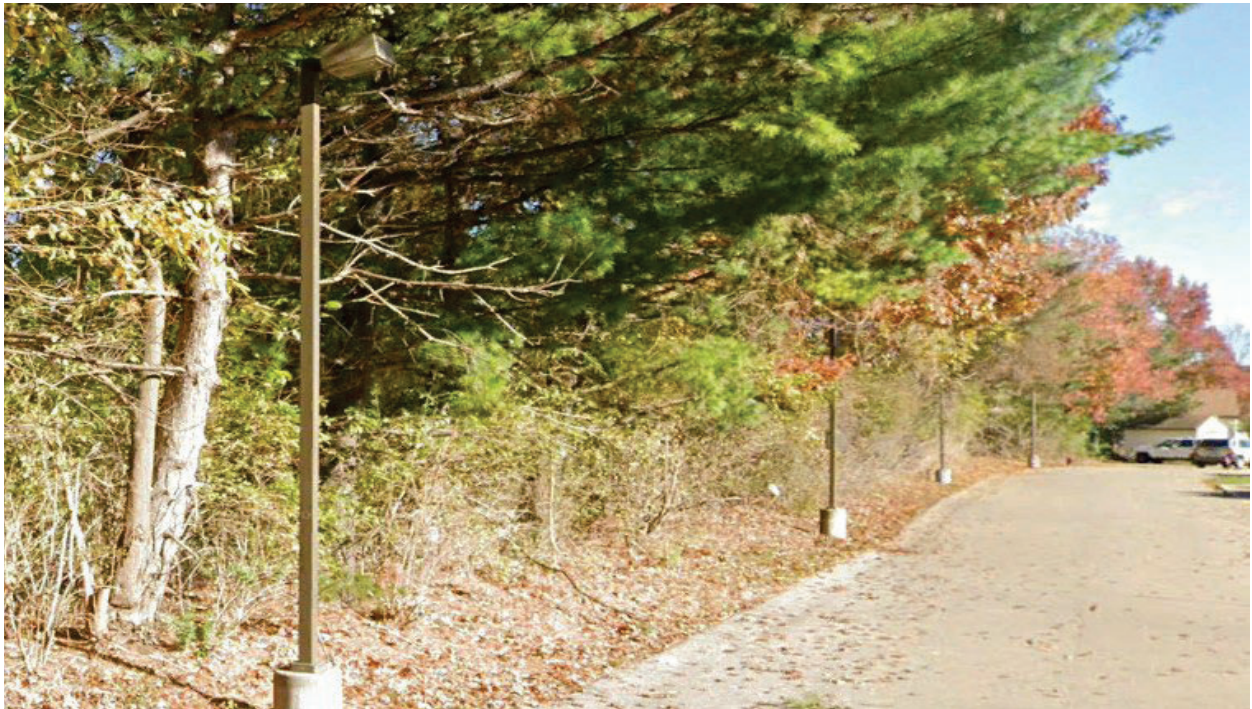
*Photo G.1      Pre-Clearing Conditions*

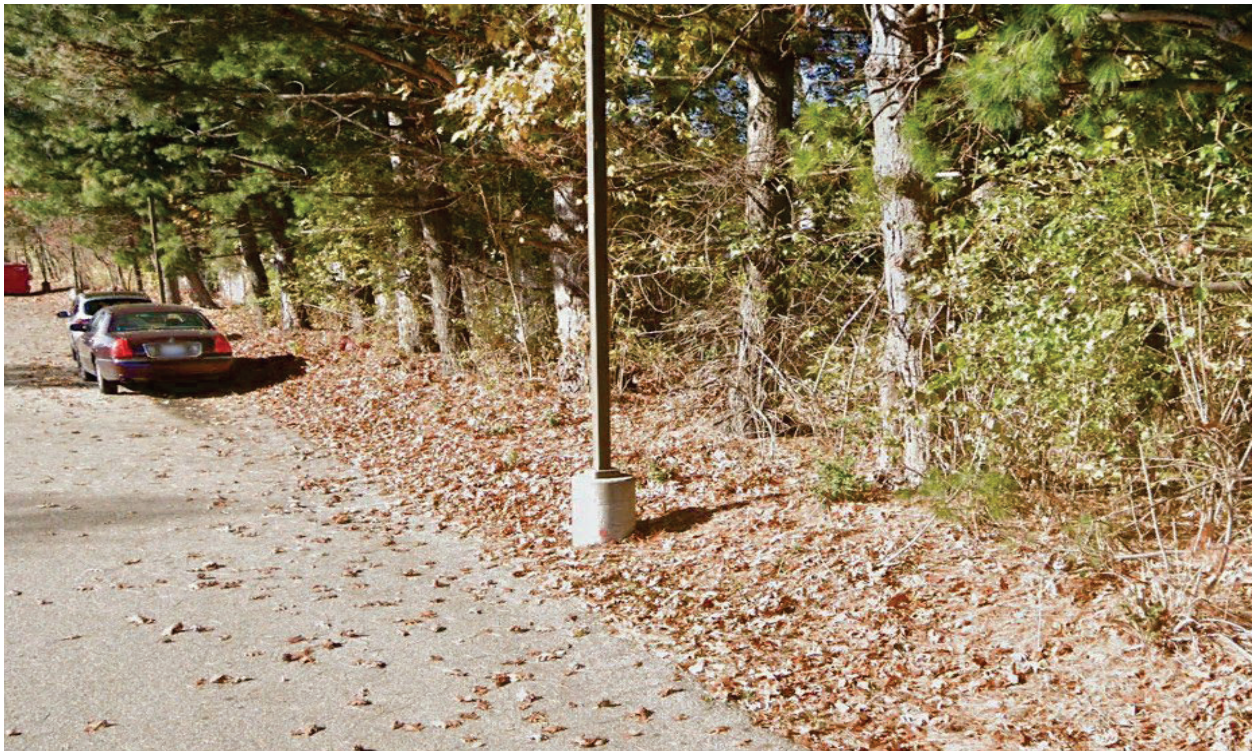
*Photo G.2      Pre-Clearing Conditions*

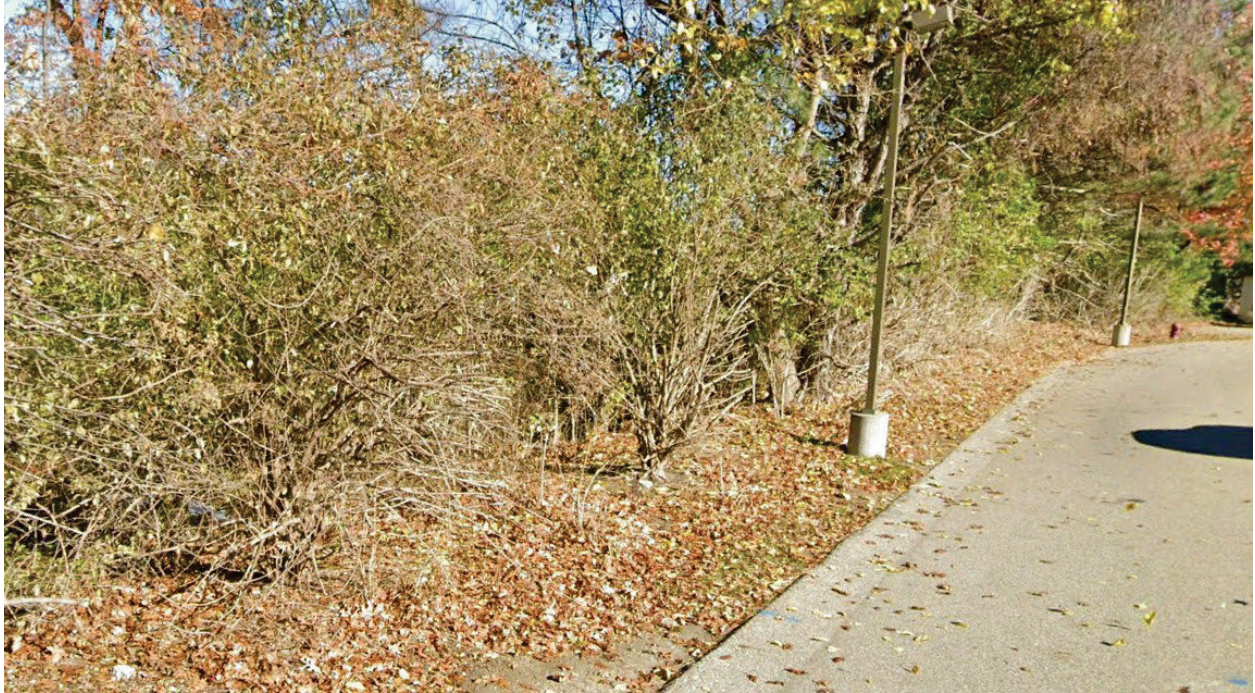
**Photo G.3**      **Pre-Clearing Conditions**

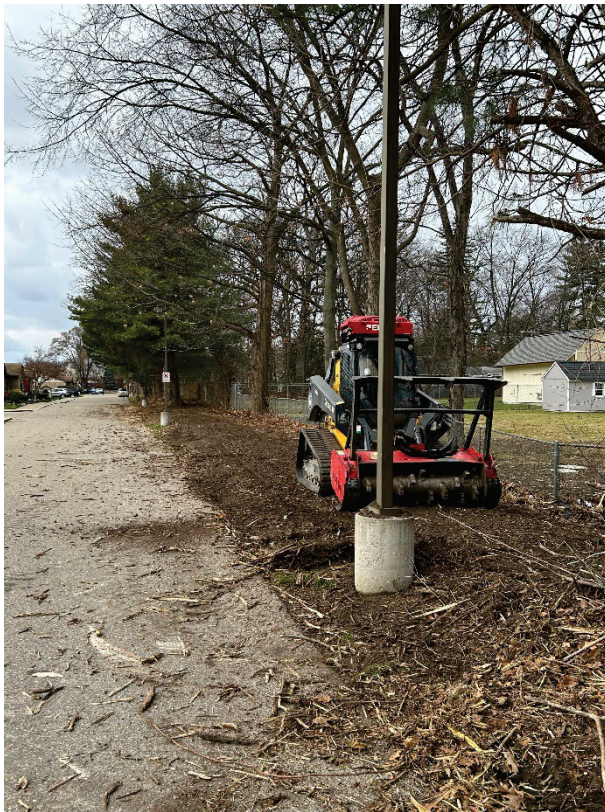
**Photo G.4**      **Brush Clearing**

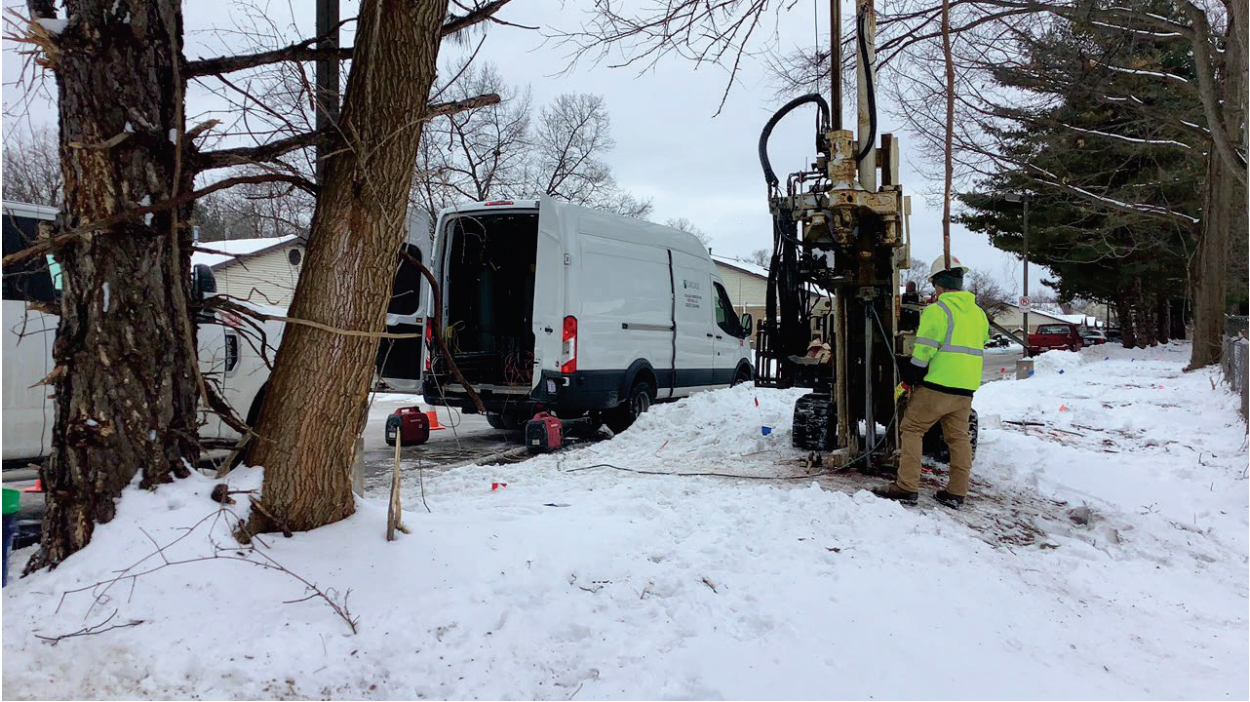
Photo G.5      *MiHPT Drilling/Pre-injection Soil Characterization*

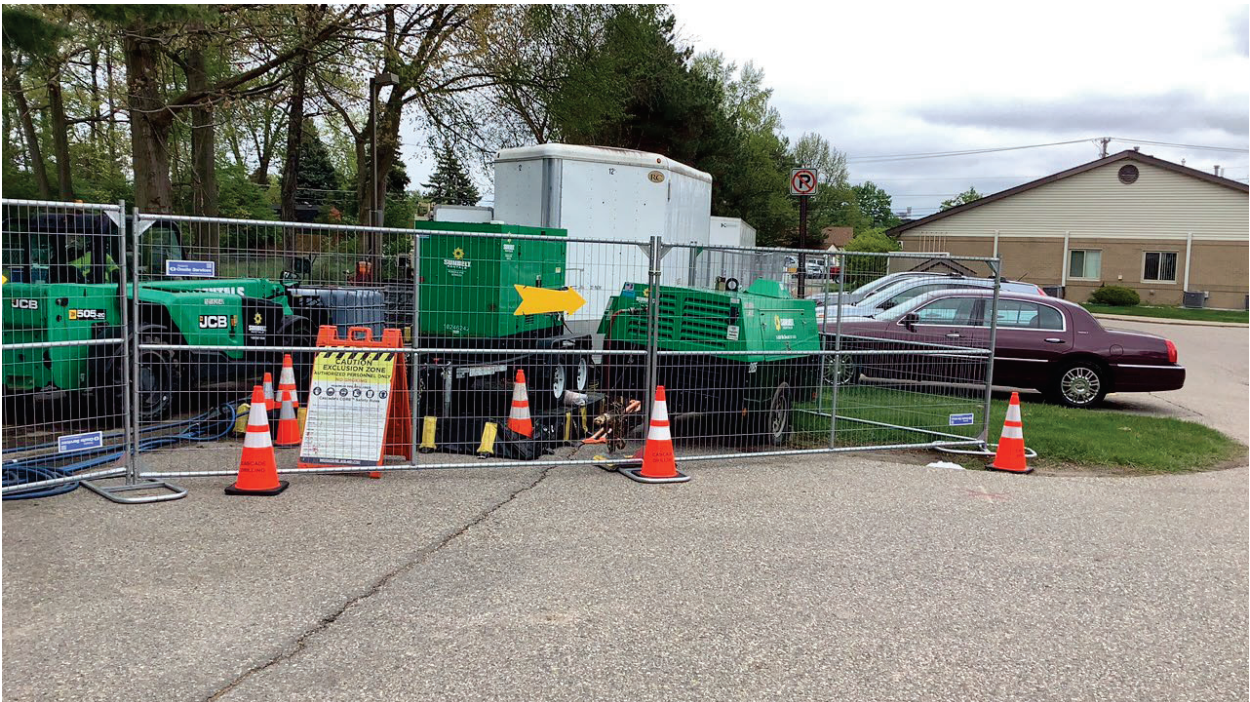
Photo G.6      *Work Area Safety Barricade*

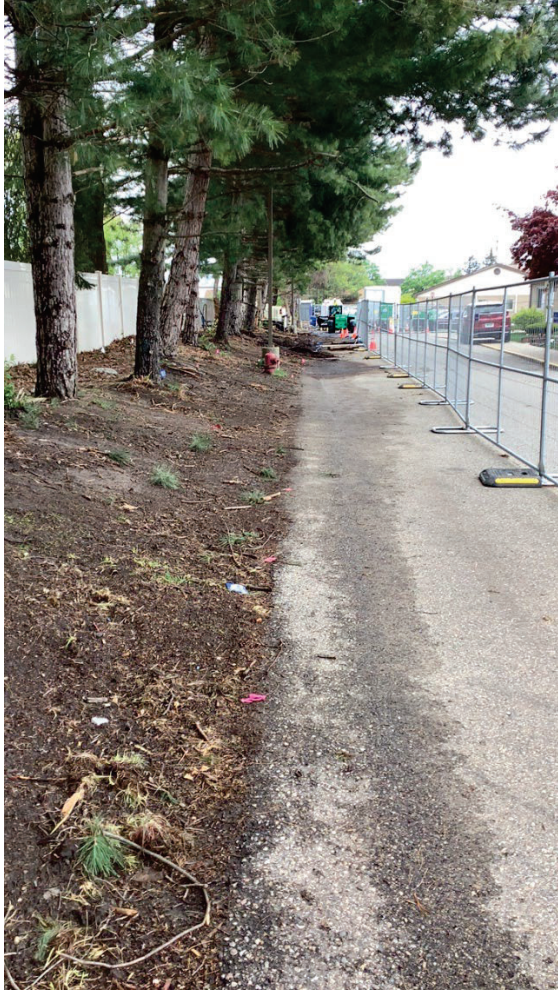
Photo G.7      *Inside Work Area Fence – West End*

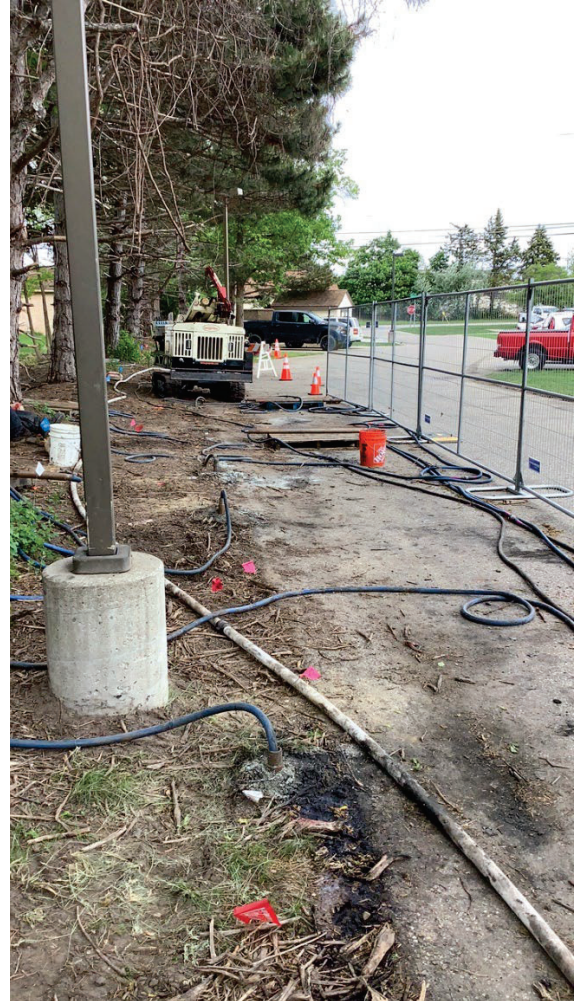
Photo G.8      *Inside Work Area Fence – East End*

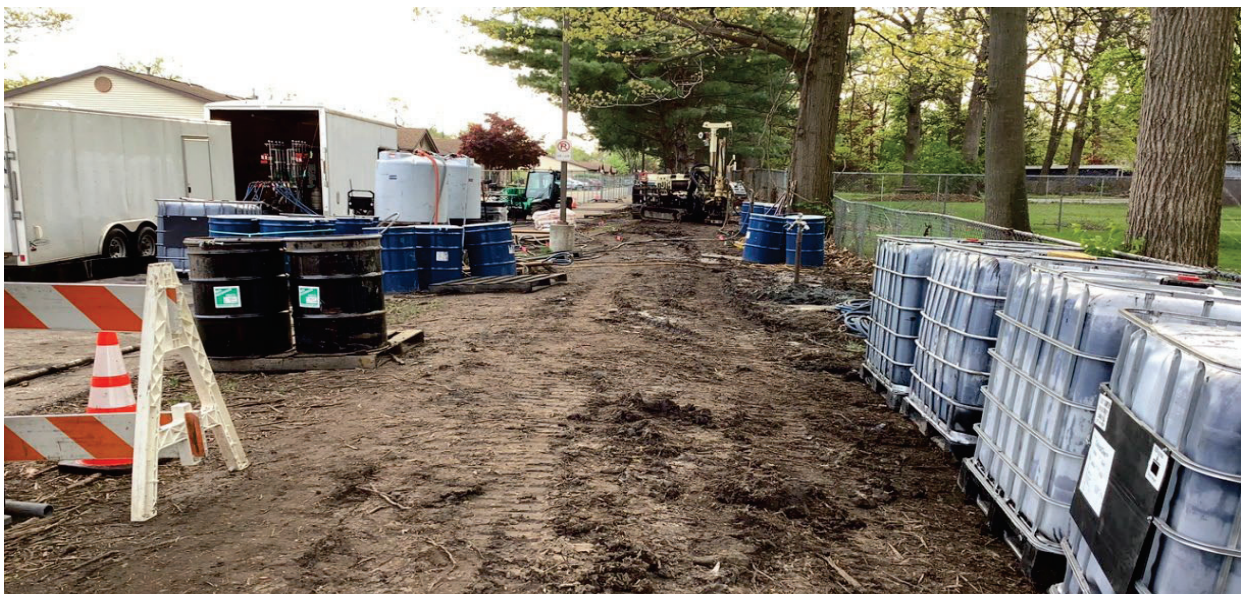
Photo G.9      *Inside Work Area – Center of Work Area*

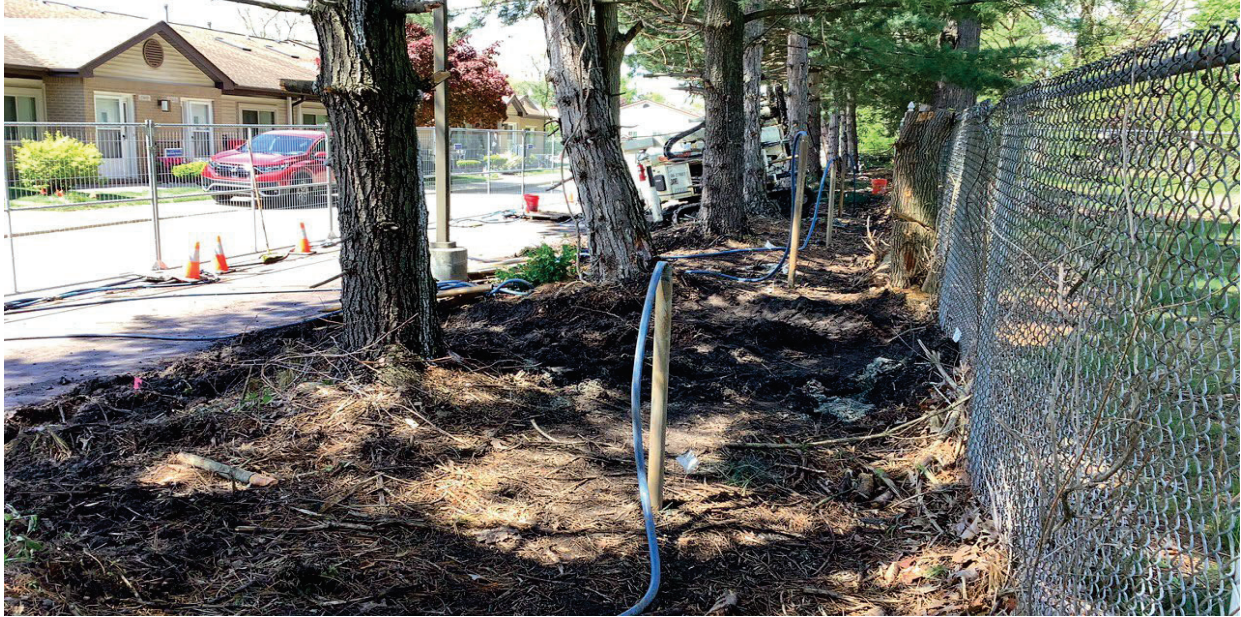
*Photo G.10 North Row Injection Points*

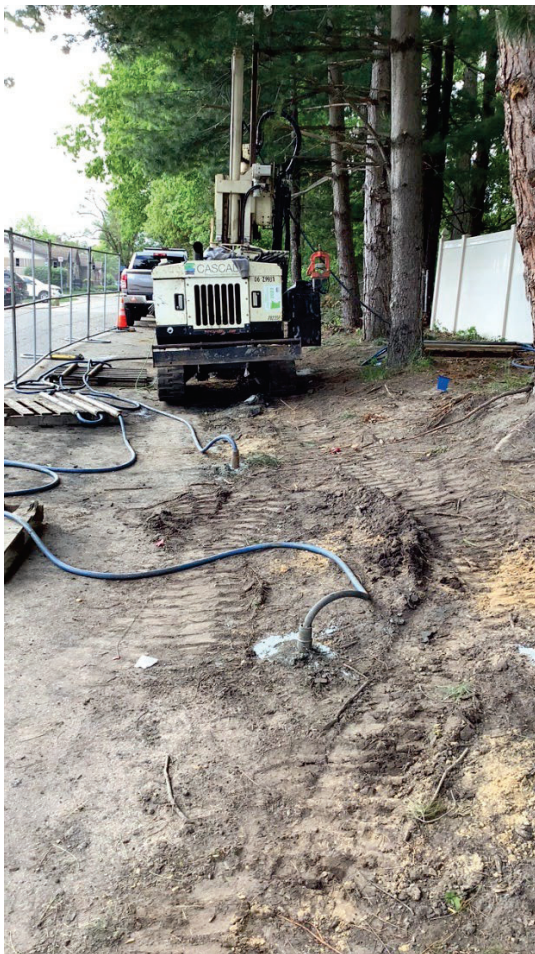
*Photo G.11 South Row Injection Points and Geoprobe advancing an injection point*

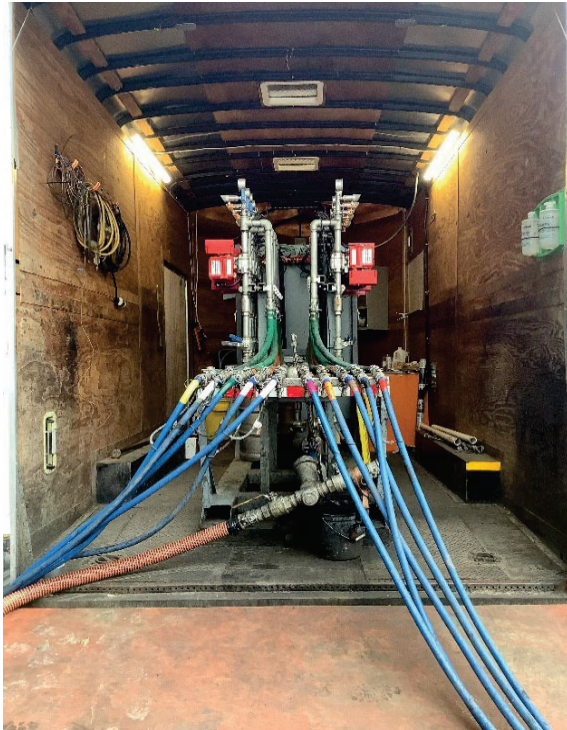
Photo G.12 Pathfinder Injection System Manifold

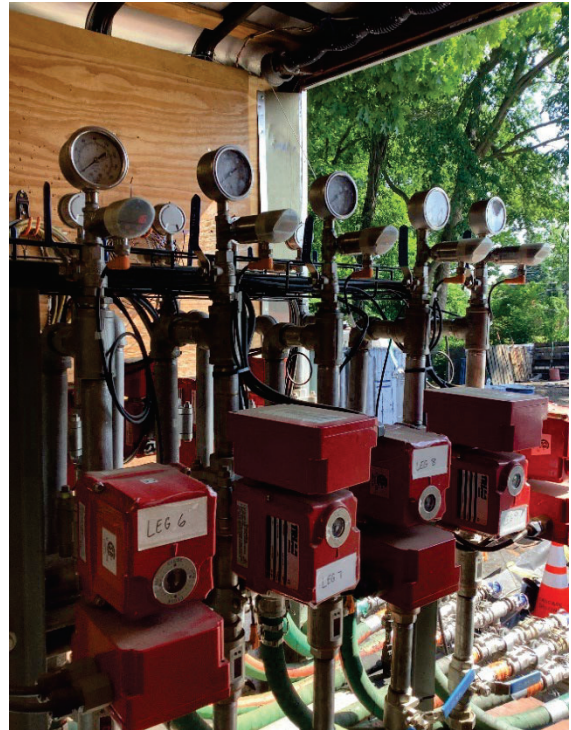
Photo G.13 Pathfinder Pumps and Pressure Gauges

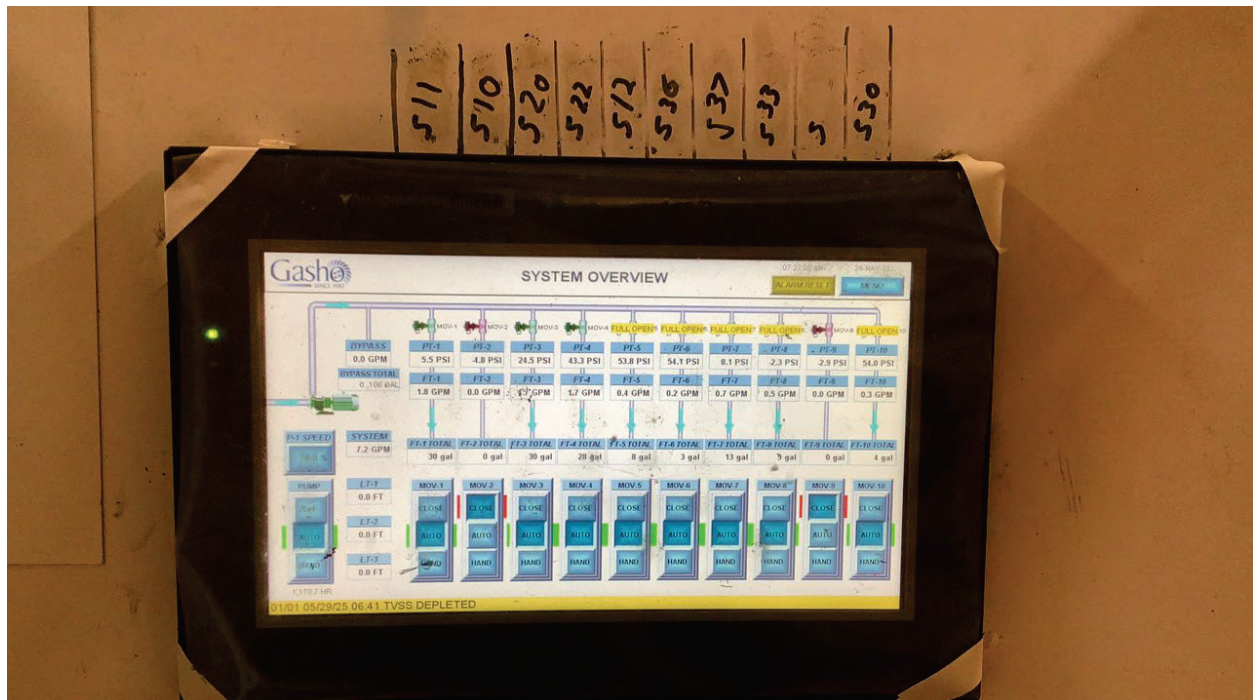
Photo G.14 Pathfinder Injection System with Flowrate and Pressures

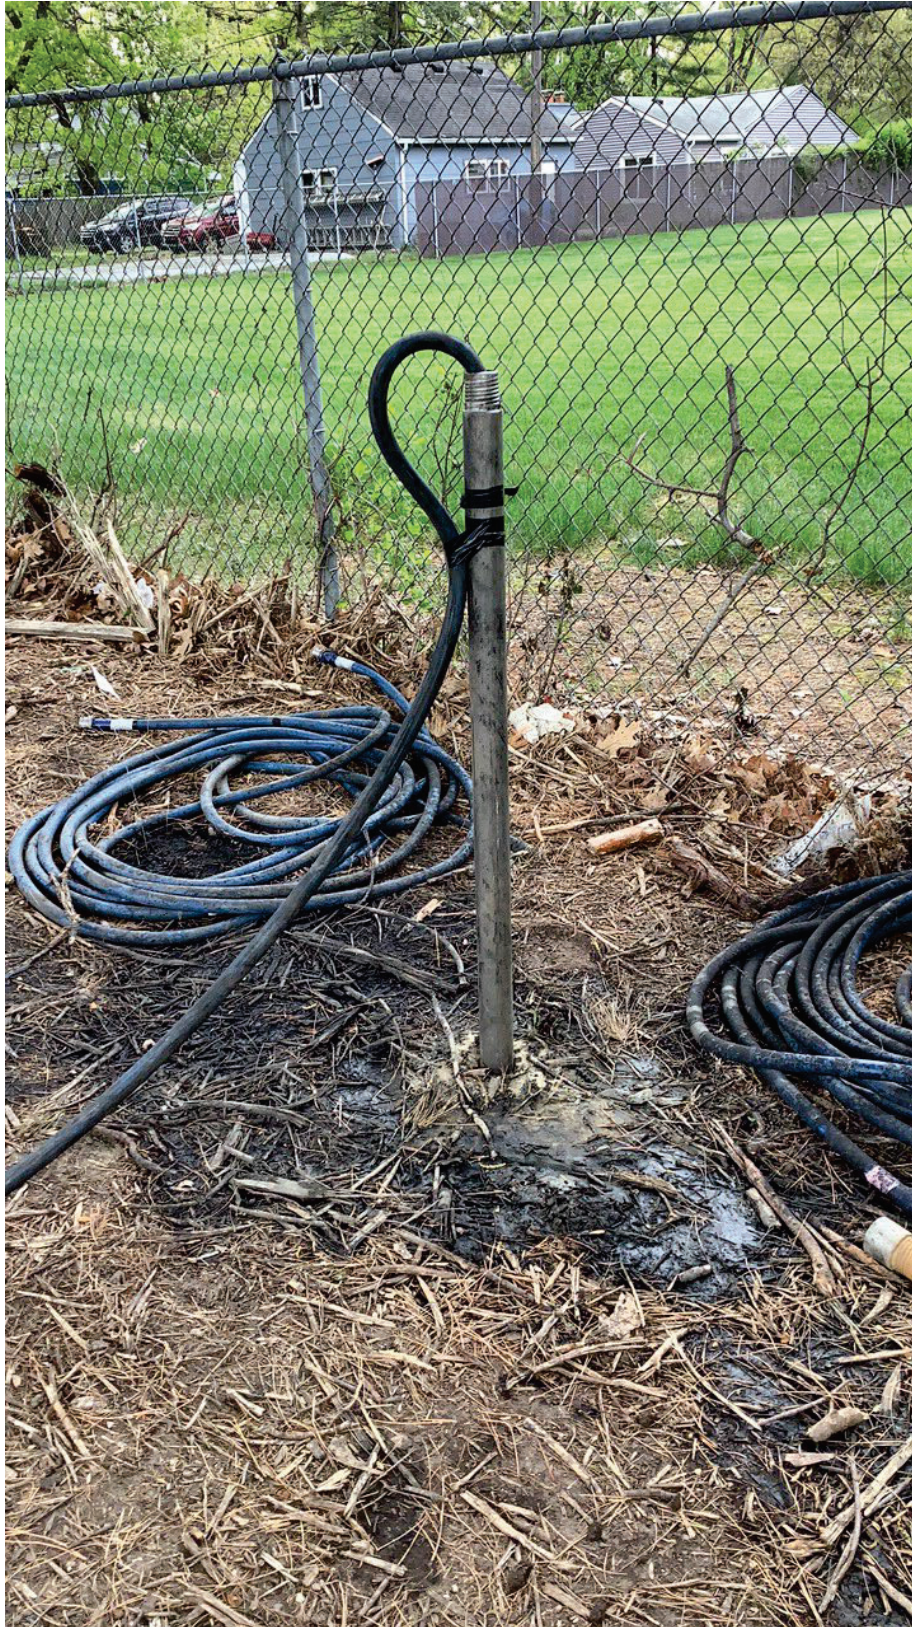
*Photo G.15      Example of Shallow Interval Daylighting – N24*

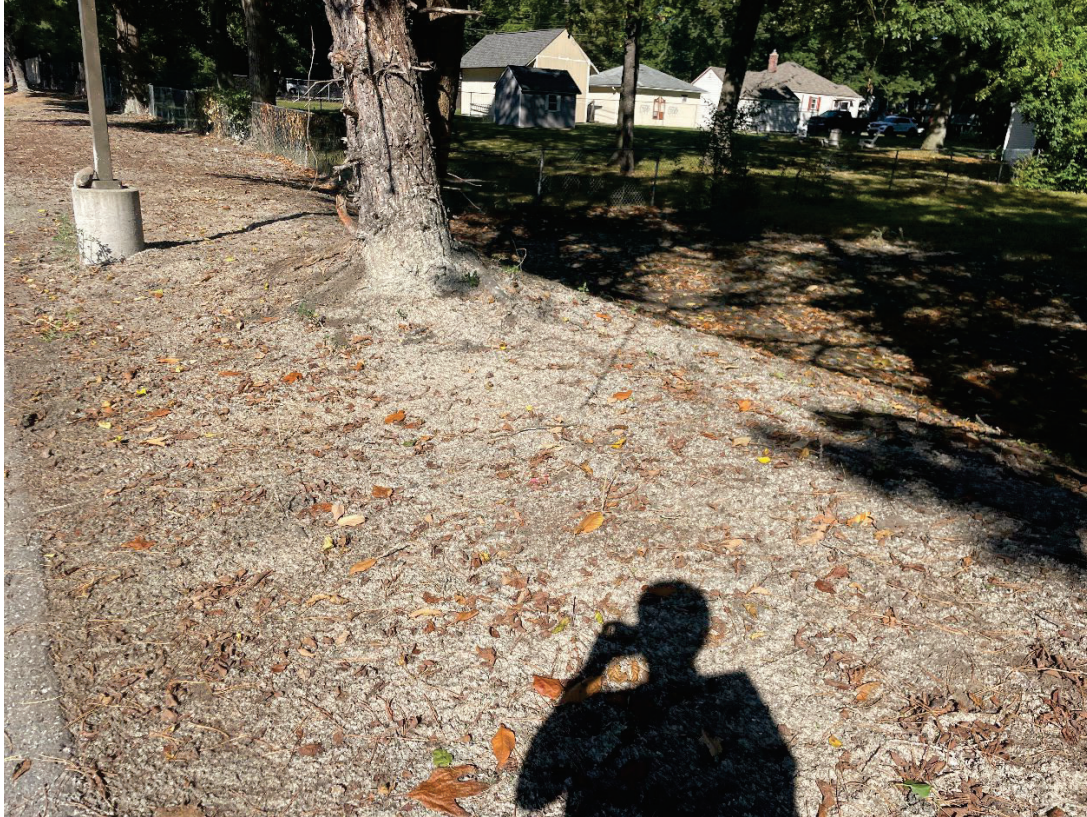
**Photo G.16**      **Restoration – East end looking West**

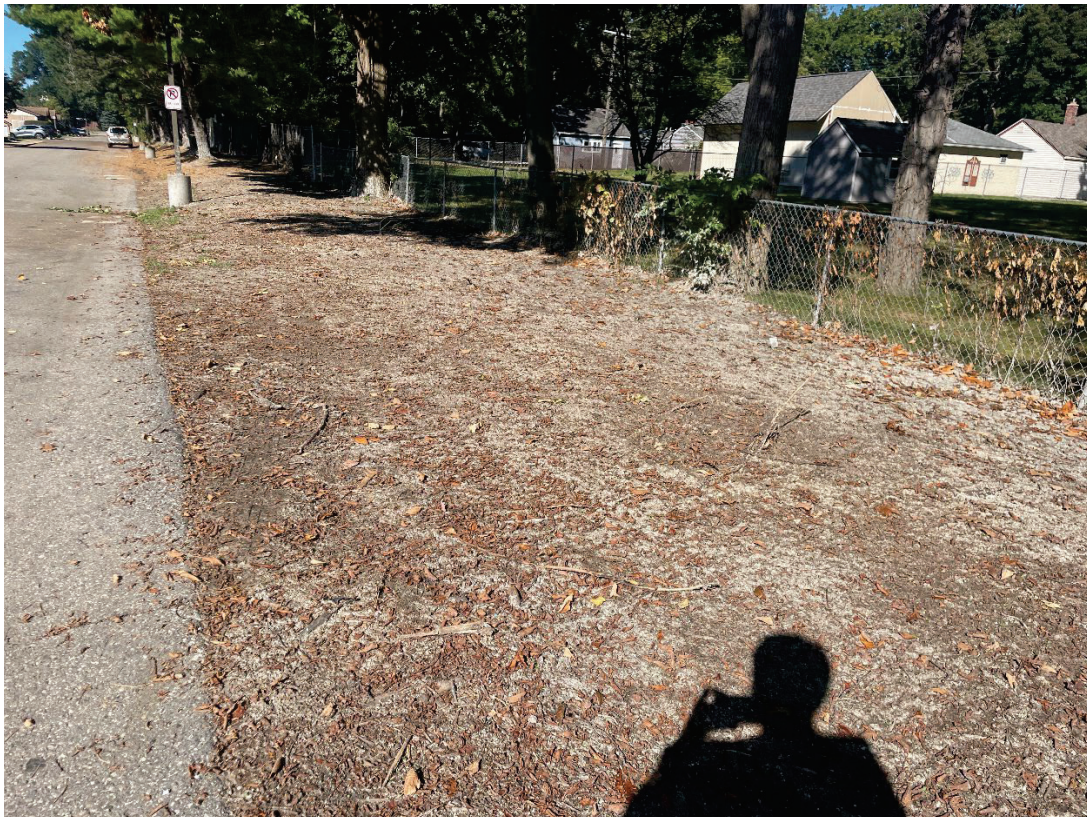
**Photo G.17**      **Restoration - Looking West**

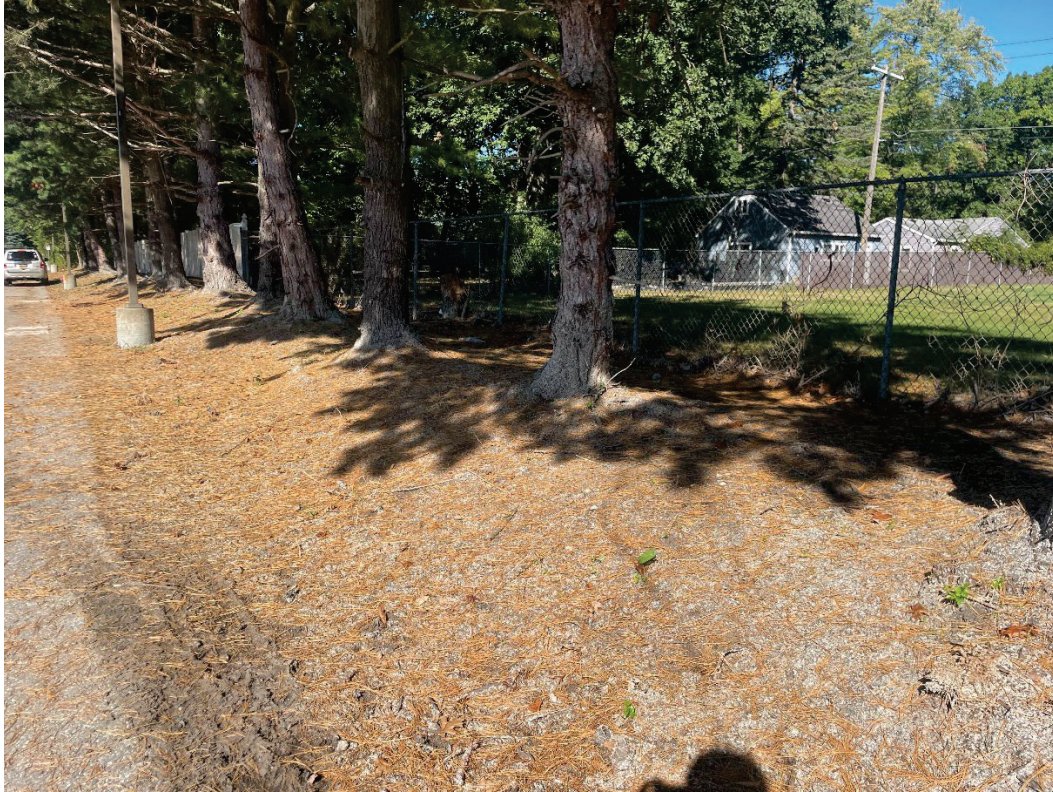
**Photo G.18**      **Restoration - Looking West**

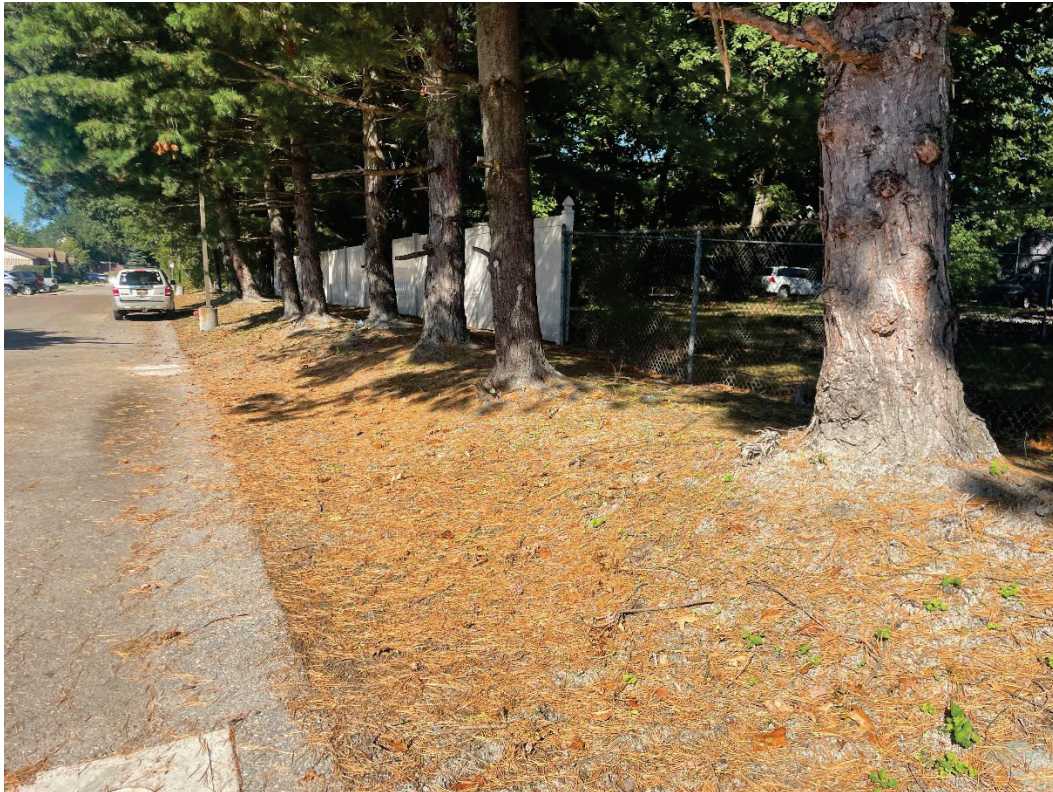
**Photo G.19**      **Restoration - West Section**
