**Summary and Update of Site Investigation  
Buick City  
Report to EGLE  
July 15, 2020**

RACER TRUST  
BUICK CITY  
FLINT, MICHIGAN

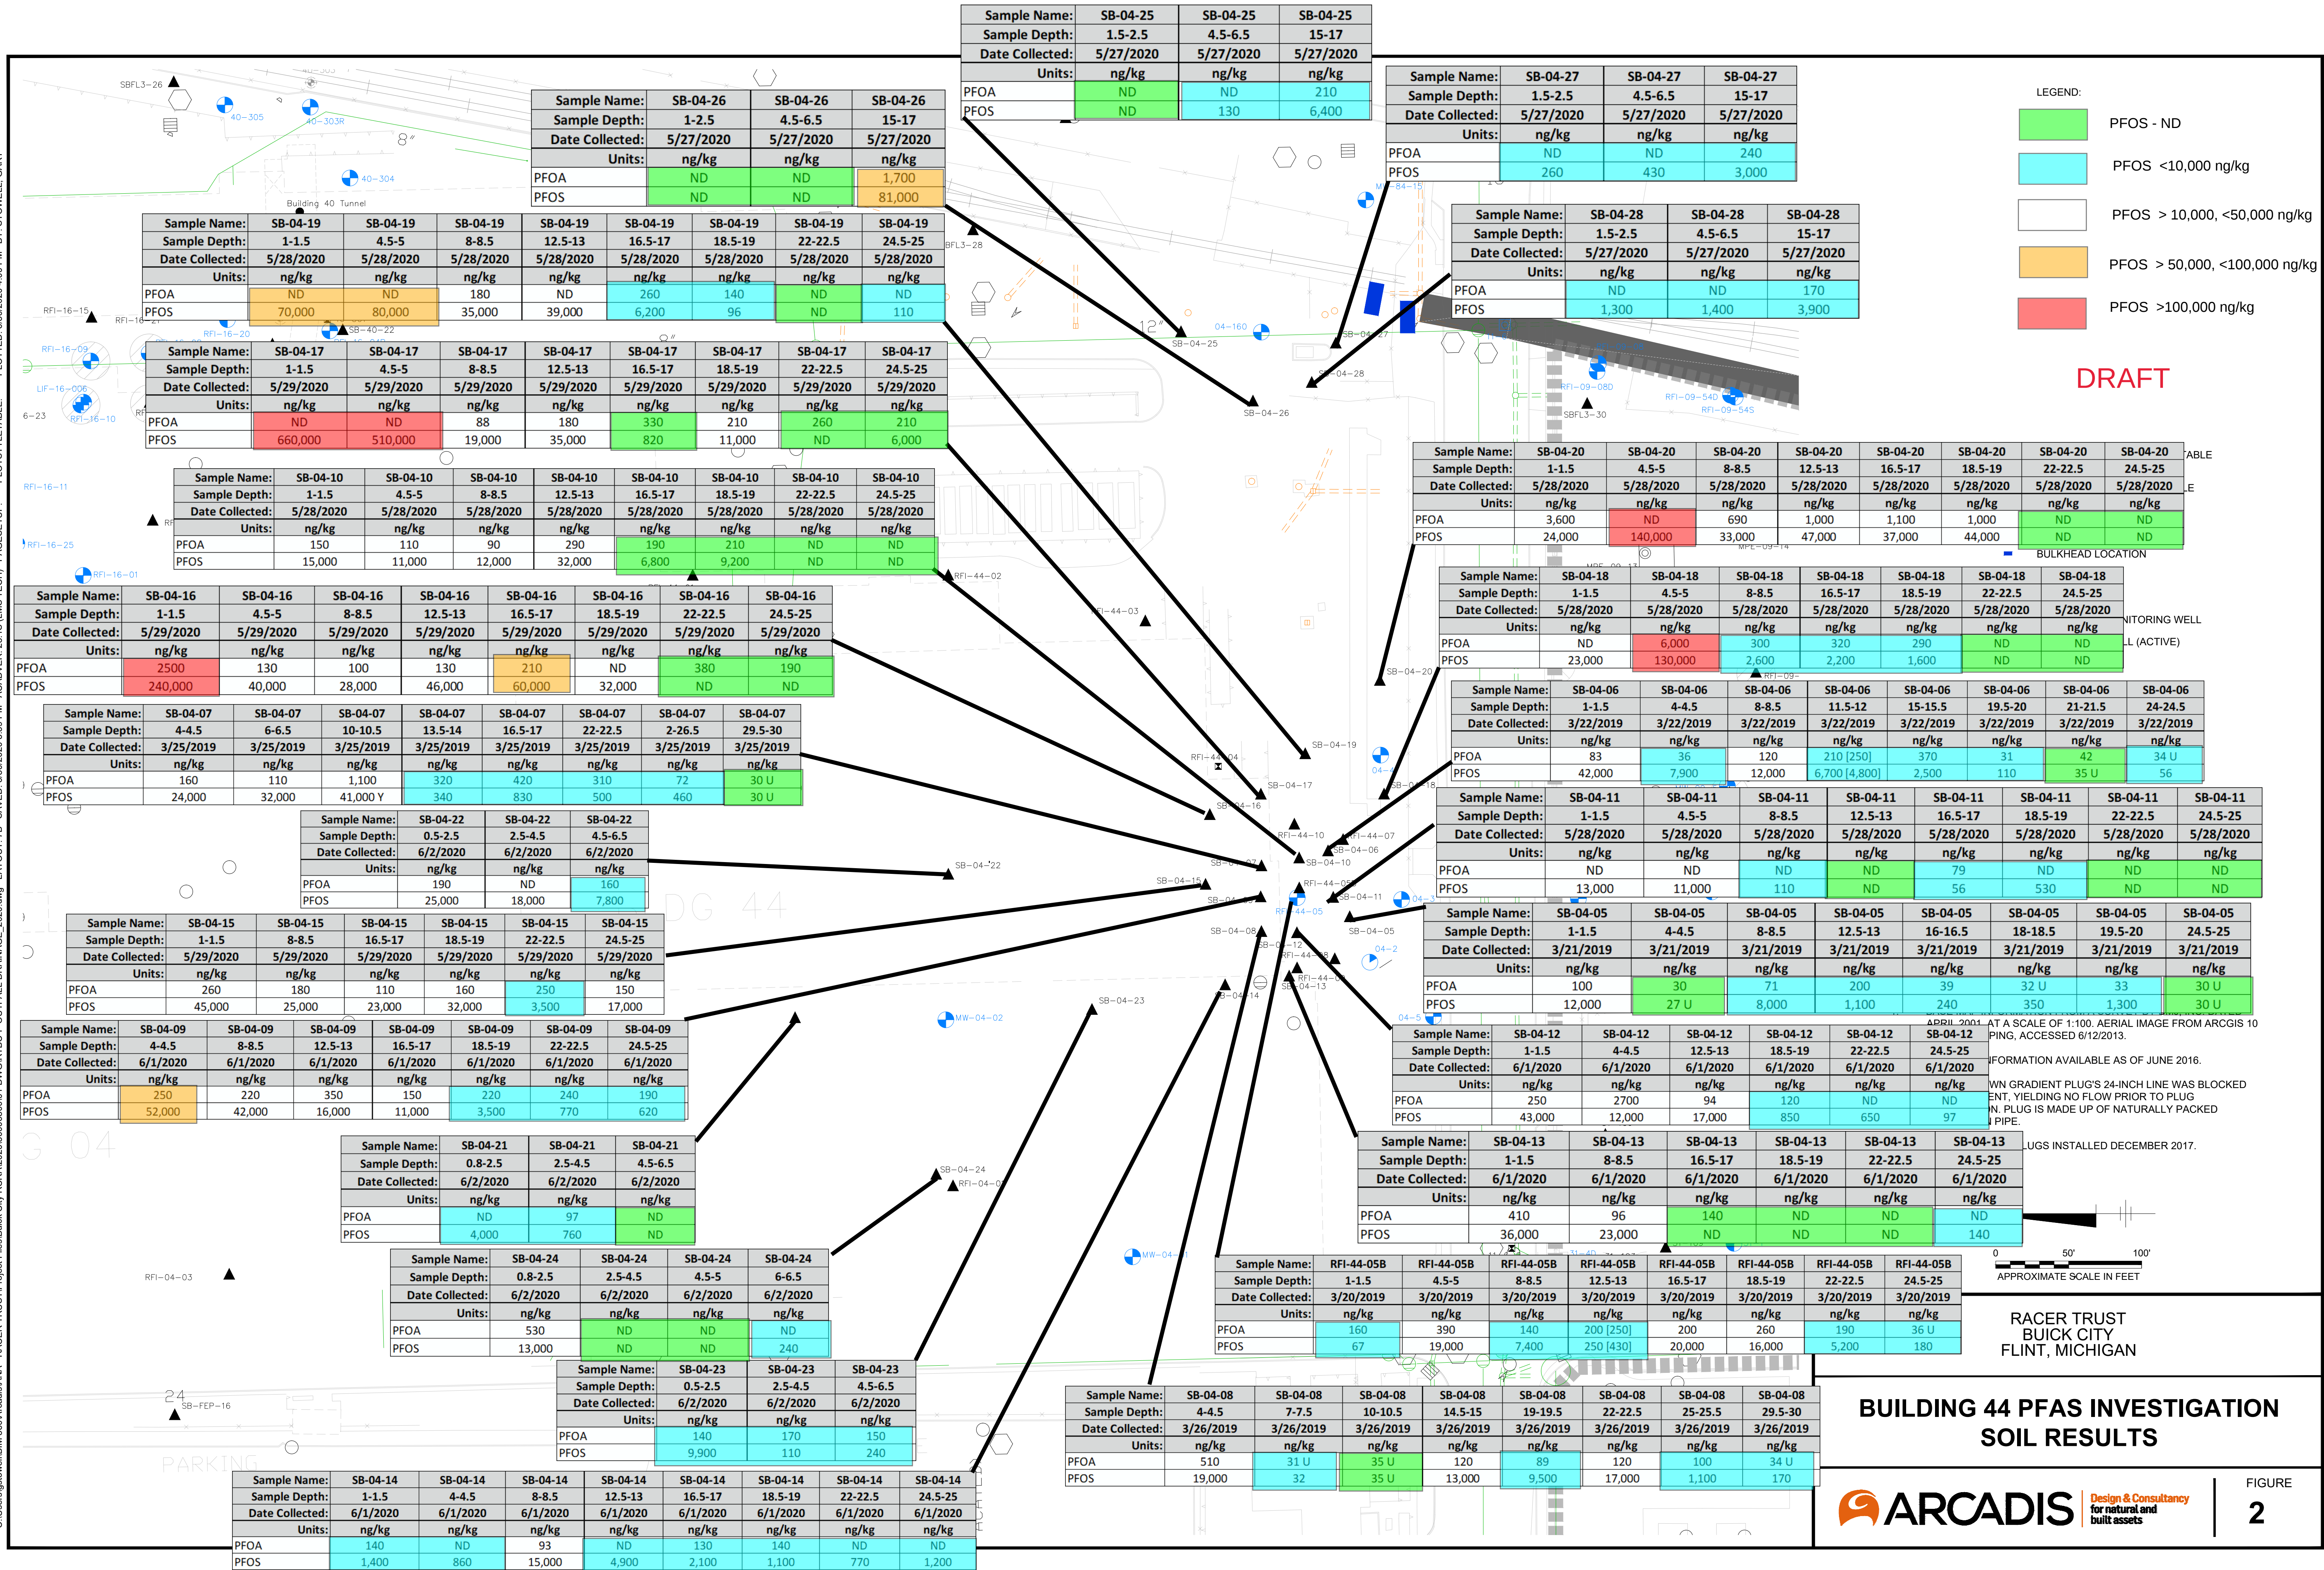
## OUTFALL 002 SEDIMENT SAMPLING LOCATIONS

Finally, with respect to **Outfall 002** the Buick City Site's contribution to 002 will be reconnected with the completion of the 003 reroute. To establish baseline conditions before the 003 reroute is reconnected, samples of sediments and stormwater were collected from the outfall 002 stormwater line downgradient of the previously installed bulkhead to assess the condition of 002 before the reroute is completed and activated. Elevated levels of PFAS were found in both water and sediment, but not in adjoining groundwater samples.(see **Exhibits 4-1, 4-2, and 4-3**)
