RACER TRUST LANSING PLANTS 2, 3, & 6

2024 Fourth Quarter Progress Report | January 15, 2024

Site Introduction

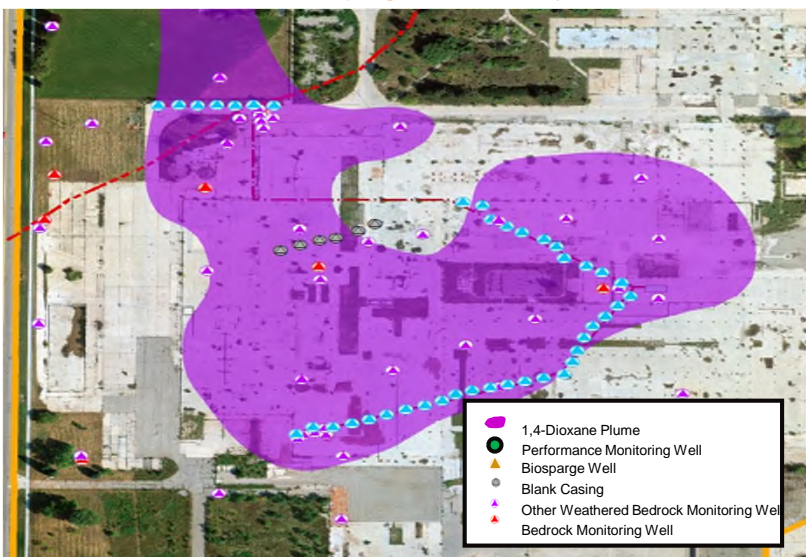
Plant 2 Biosparge Transect Layout

2016 Pilot Test Biosparge Points
2018 Pre-Design Study Biosparge Points With Sand Enhancements
Weathered Bedrock Monitoring Well

- 5 transects with 48 air sparge wells across Plants 2 and 4
- Nearly 5 miles of air hose and an air/propane injection network
- Groundwater flows from northwest to southeast and is cleaned by each transect
- Tubing installed above grade to save on costs and to accommodate future development
- Network of monitoring wells to track treatment progress

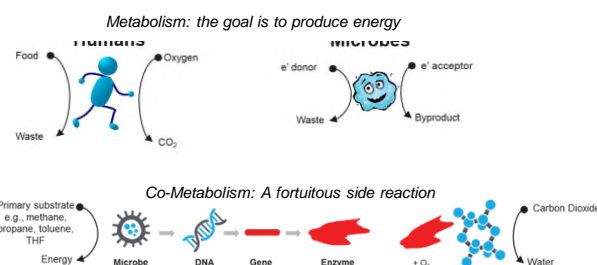
CO-METABOLIC BIODEGRADATION OF 1,4-DIOXANE:

Propane + Oxygen + Microbes = 1,4-Dioxane Treatment
