# **RACER TRUST LANSING PLANTS 2, 3, & 6**

**2021 Second Quarter Progress Report | July 15, 2021**

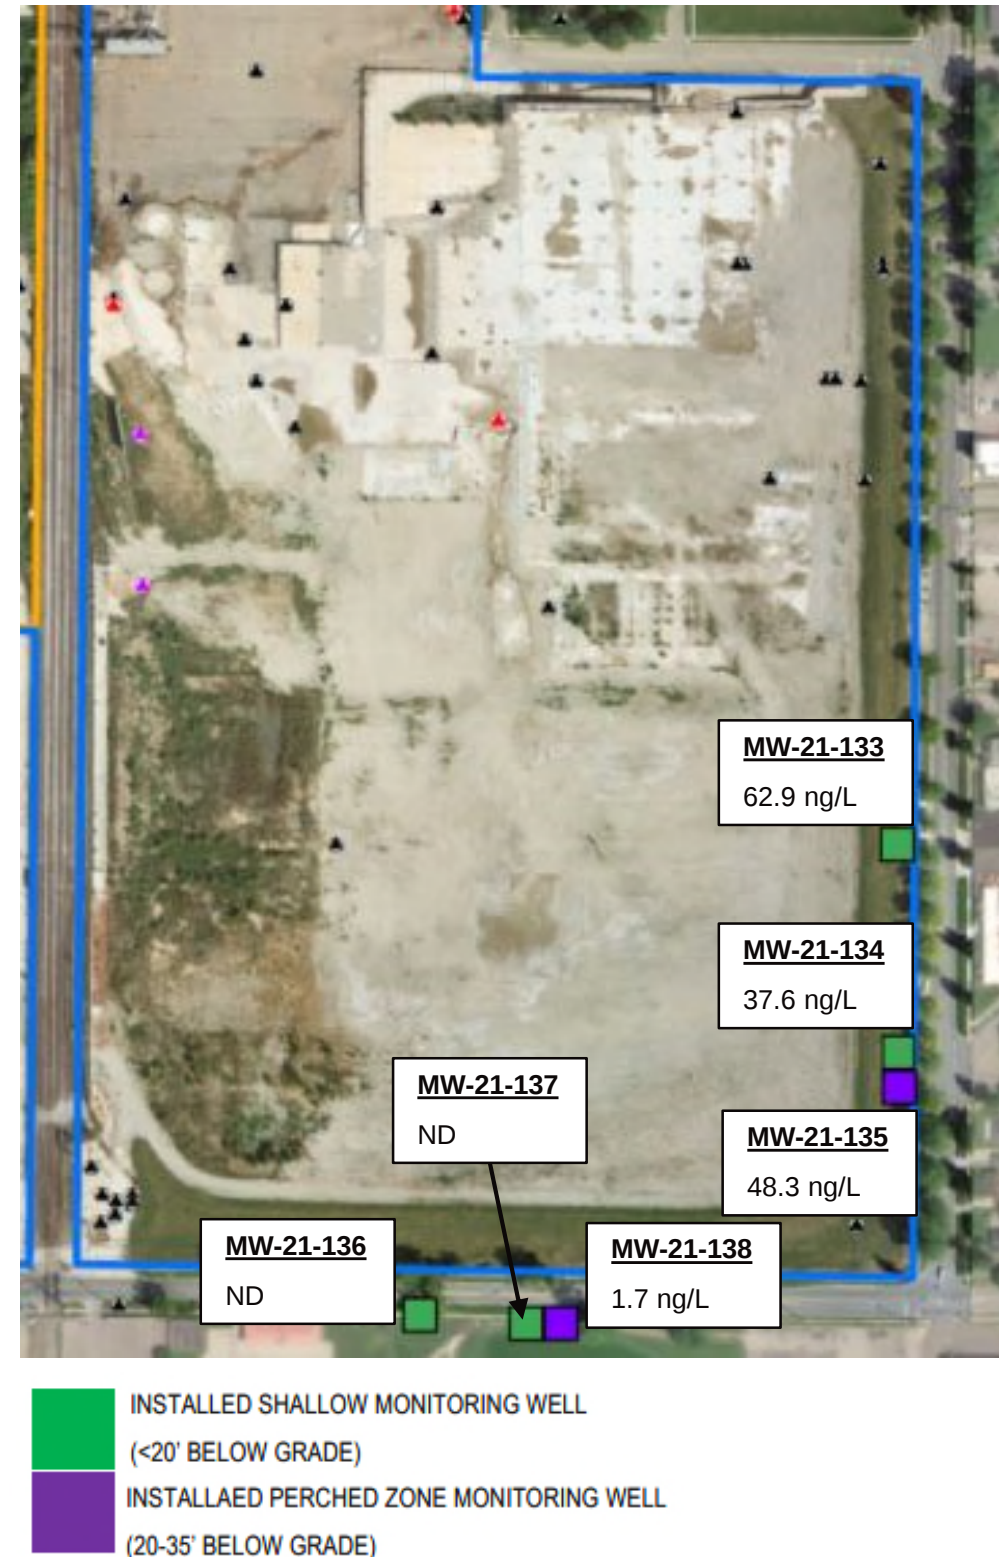
- Work completed in March 2021
- Installed three on-site monitoring wells on Plant 6 along the eastern property boundary to facilitate monitoring of PFAS identified in previous investigations

- Installed three off-site monitoring wells within the southern right of way of Michigan Avenue to provide delineation of impacts identified along the southern boundary of Plant 6

- Groundwater collected from the monitoring wells installed along the eastern portion of Plant 6 contained PFOA above EGLE drinking water criteria of 8 ng/L (parts per trillion); however, results of the wells installed along Michigan Avenue did not contain concentrations above criteria

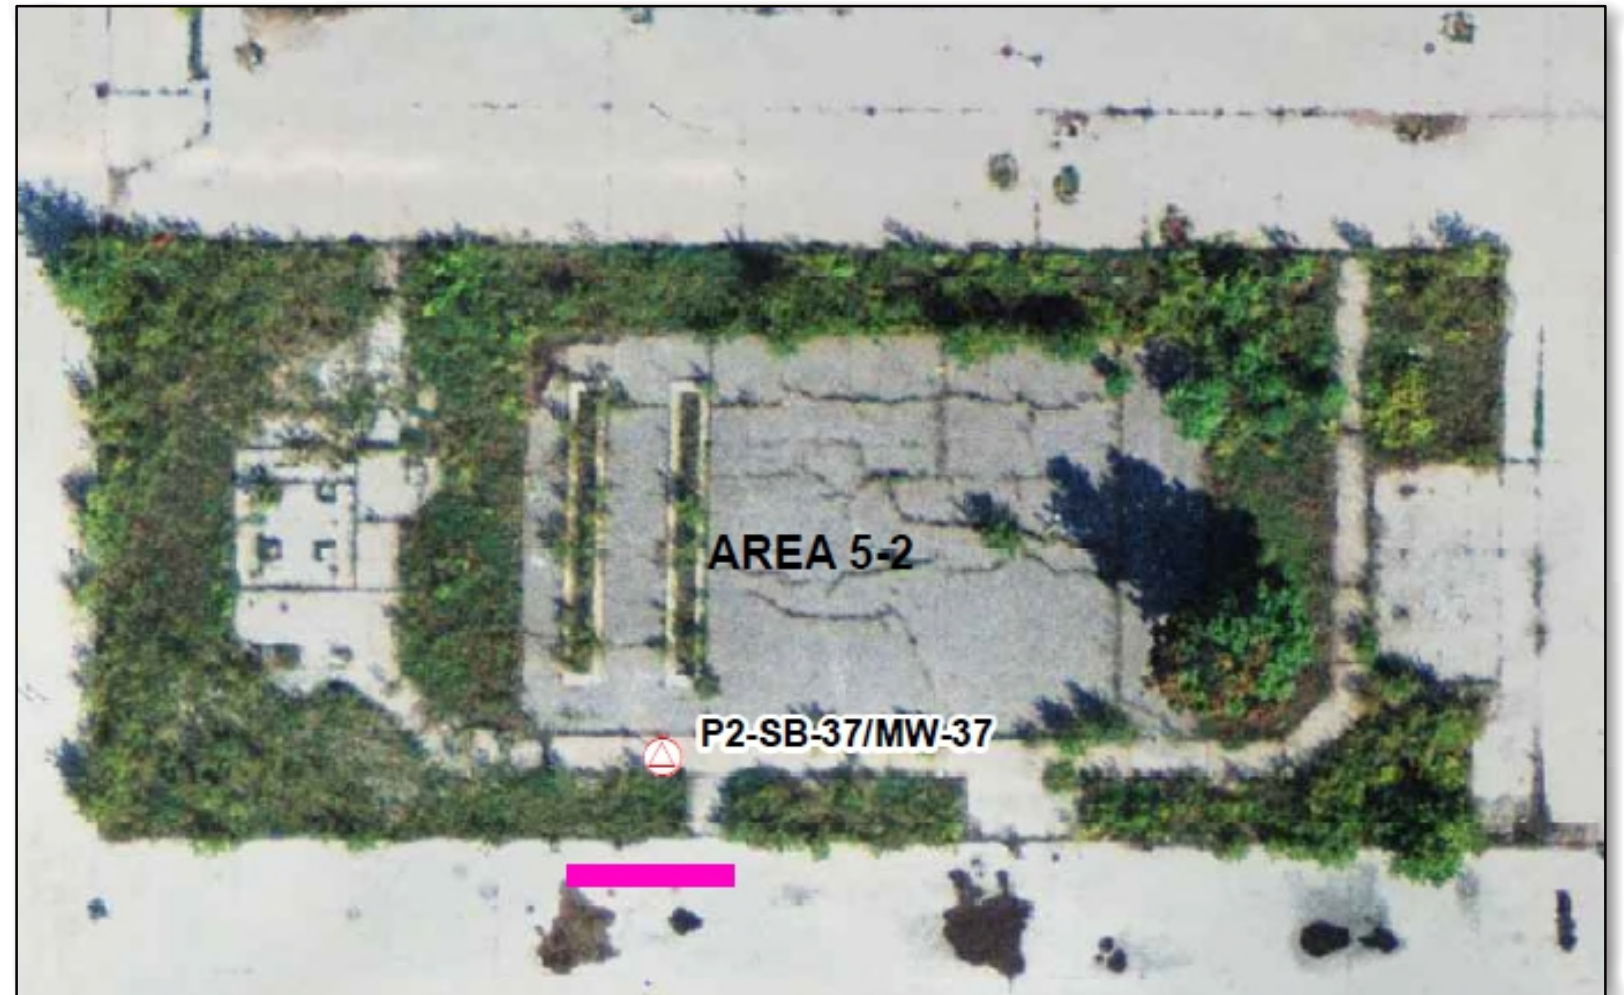
- A vault containing contaminated water is present at Plant 2 (pink box area in figure)
- A scope of work to properly clean and close the vault was submitted to EGLE on April 13, 2021 for approval
- Once approval is provided by EGLE, RACER will schedule closure activities for the vault

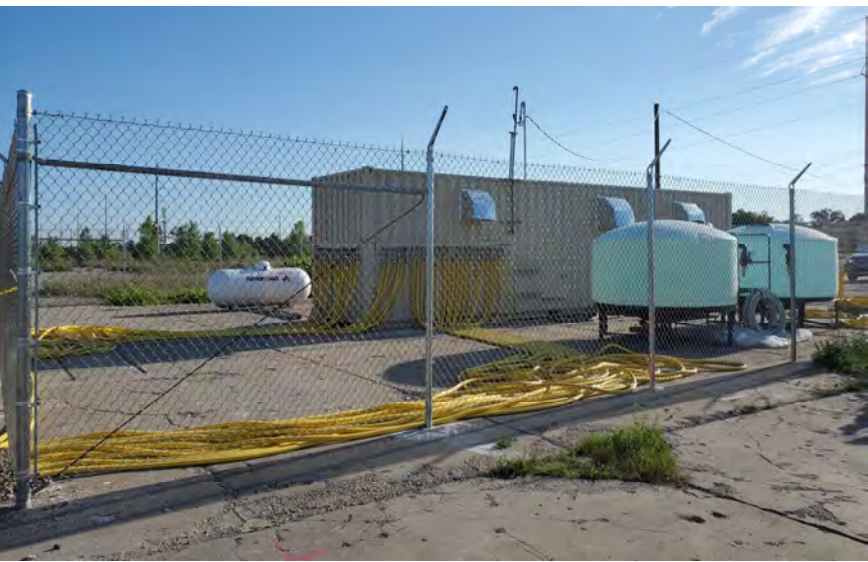
Plant 2 Biosparge Unit and Nutrient Injection Tanks
