RACER TRUST LANSING PLANTS 2, 3, & 6

2022 Second Quarter Progress Report | July 15, 2022

Site Introduction

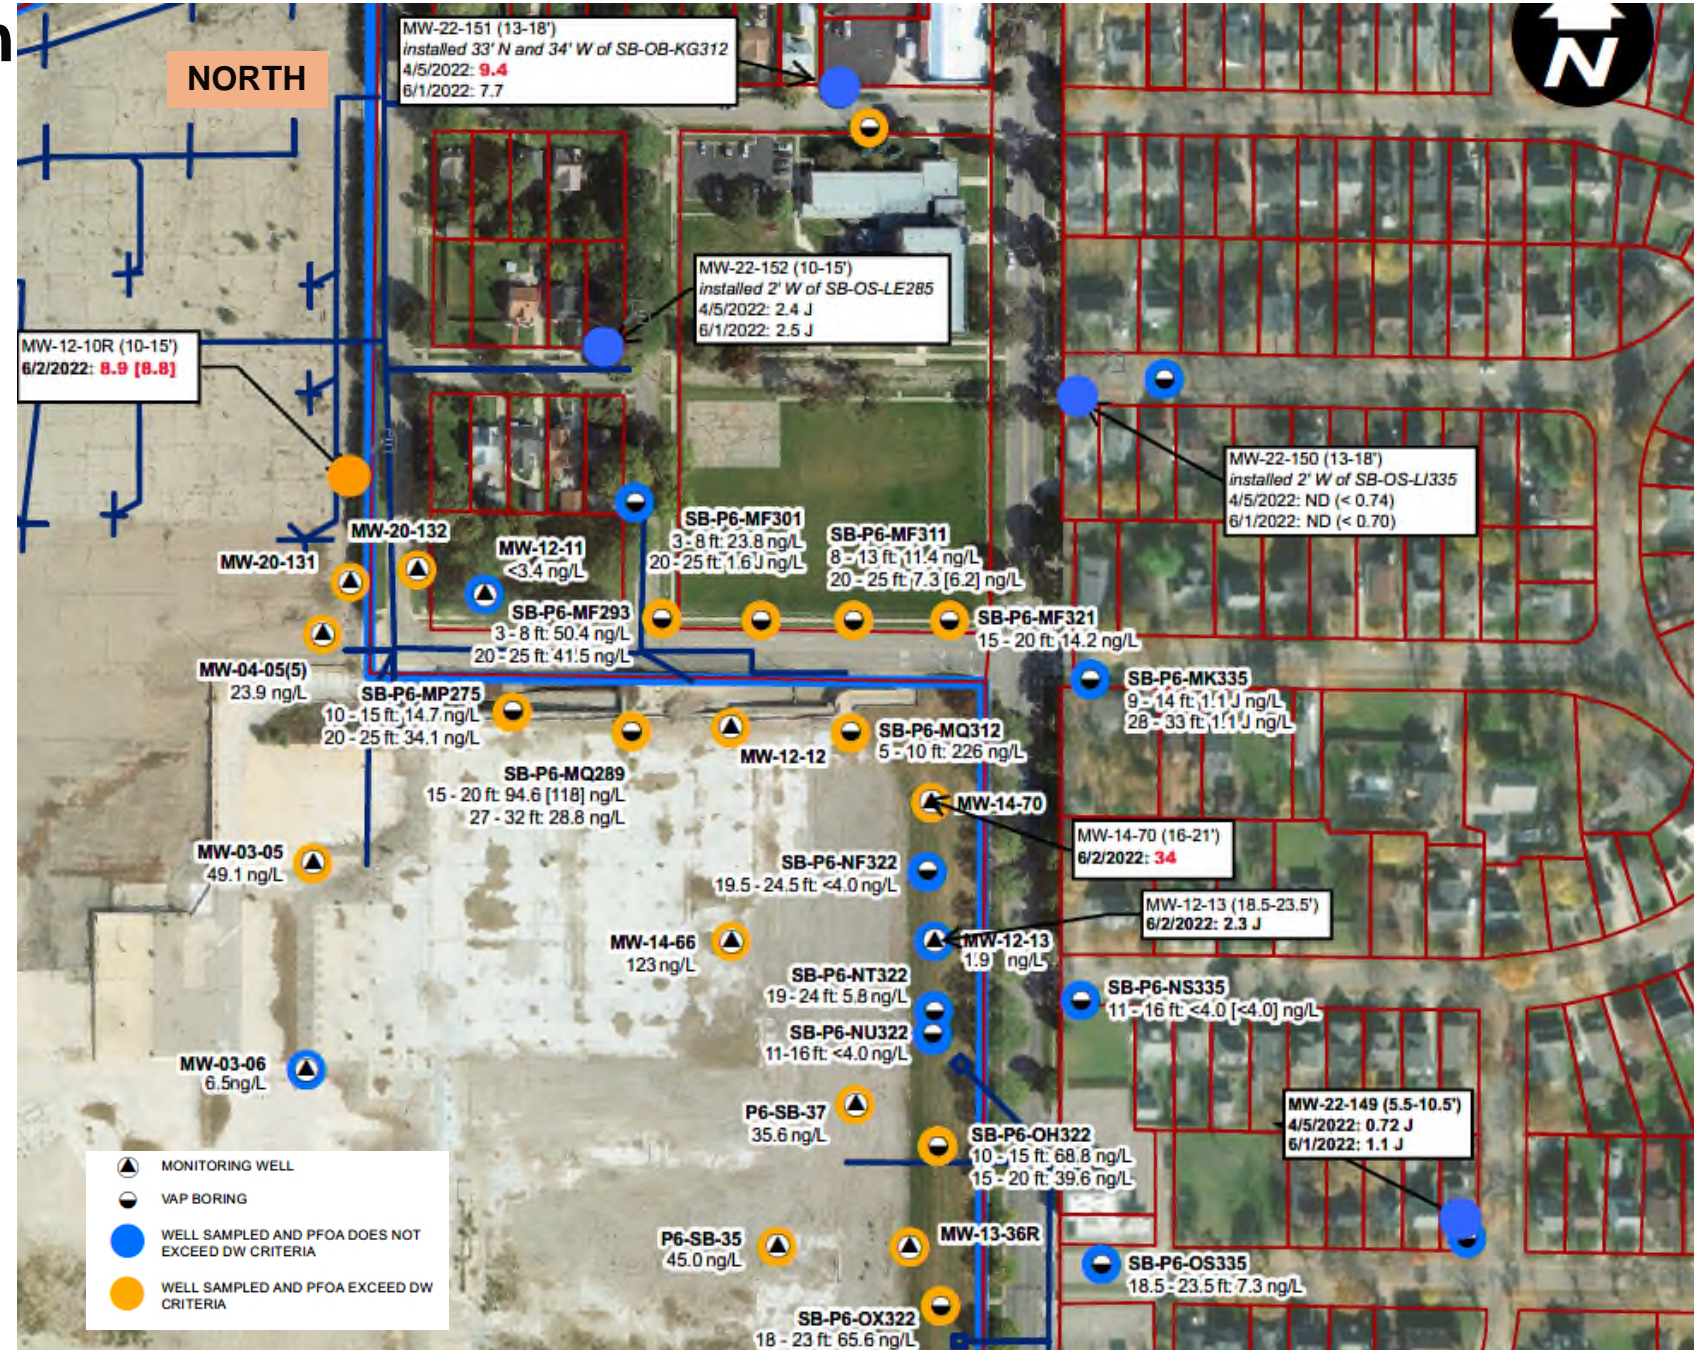
Plant 6 Off-site Investigation

- Plant 6 off-site and select on-site monitoring wells were sampled in April and June 2022
- Results are provided on the image to the right
- Northern off-site Well MW-22-151 below PFOA criteria (8 nanograms/liter [ng/L]) in June 2022

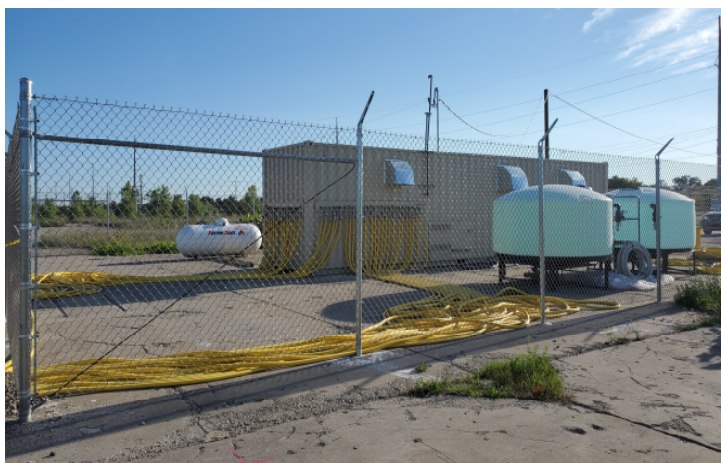
Plant 2 Biosparge Unit and Nutrient Injection Tanks
