Cleanup Progresses at Former Factory Complex

Buick City Site

Flint, Michigan

March 2019

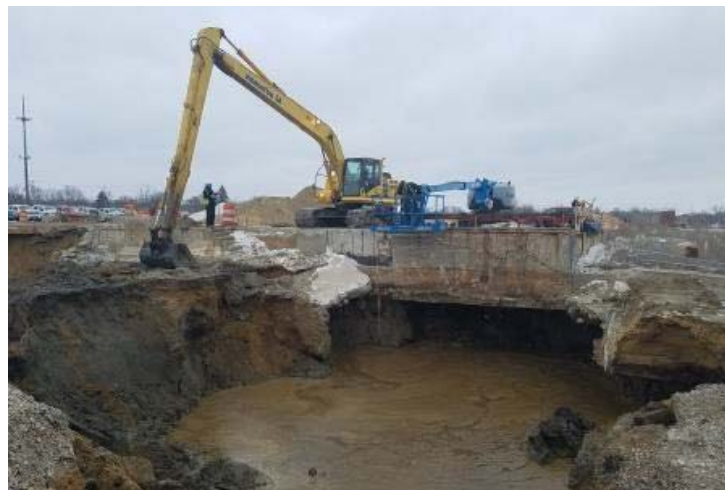
Recently completed PCB soil excavation work at Buick City

chemical called benzo(a)pyrene were dug up and disposed of in a landfill. More recently, (2018/2019) an additional 2,600 tons of soil contaminated with PCBs and some PFAS were dug up (*see photos*) and disposed of in a licensed landfill.

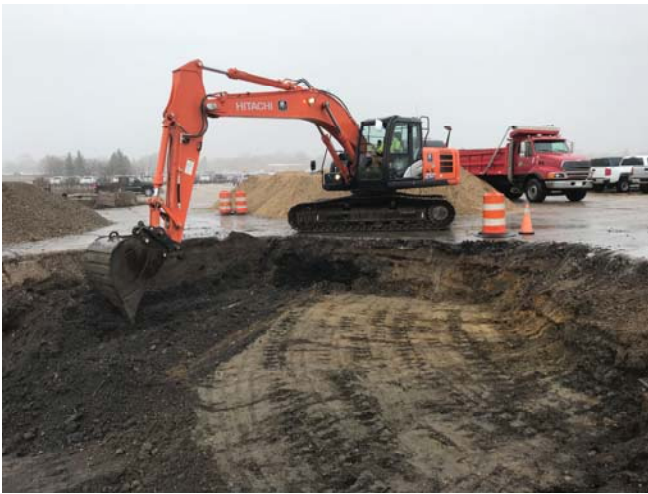
Recently completed PCB soil excavation work at Buick City
